# Pentagon & Boeing 757 Wheel Investigation

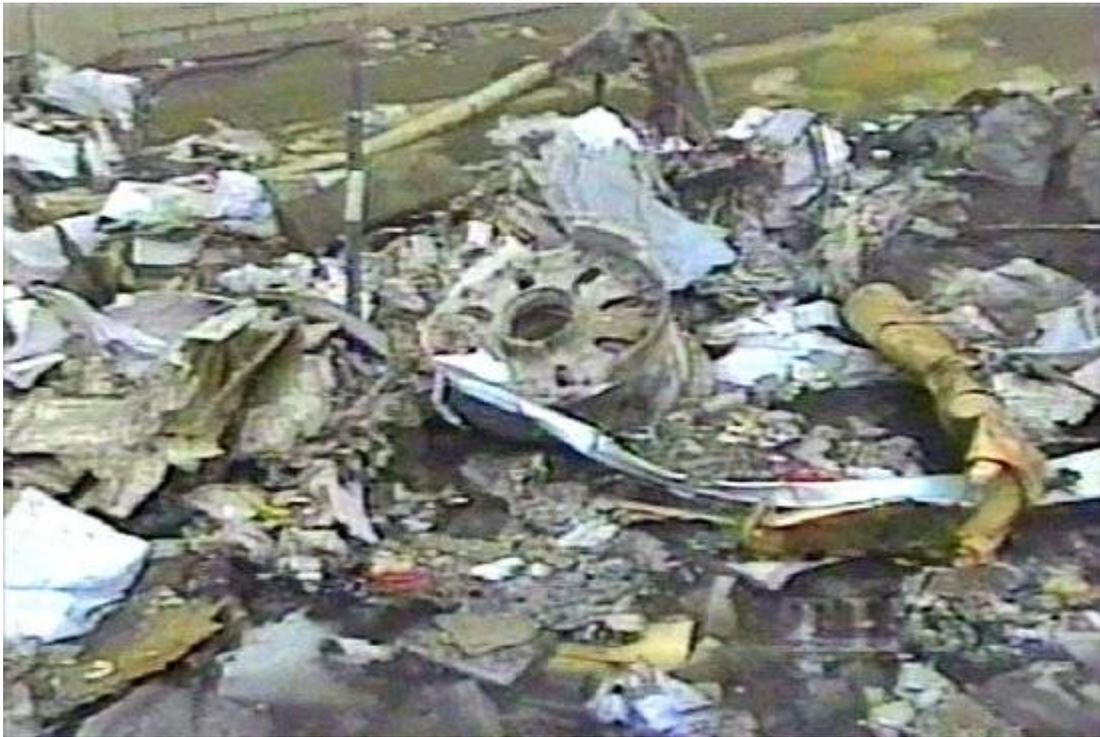
**Landing gear wheel visible at the Pentagon**

The above photo was taken at the Pentagon after the September 11 attack and contains a clearly identifiable piece of landing gear wreckage from the aircraft that impacted the building. A closer view of the item, shown below, reveals additional detail in the shape of this landing gear component.

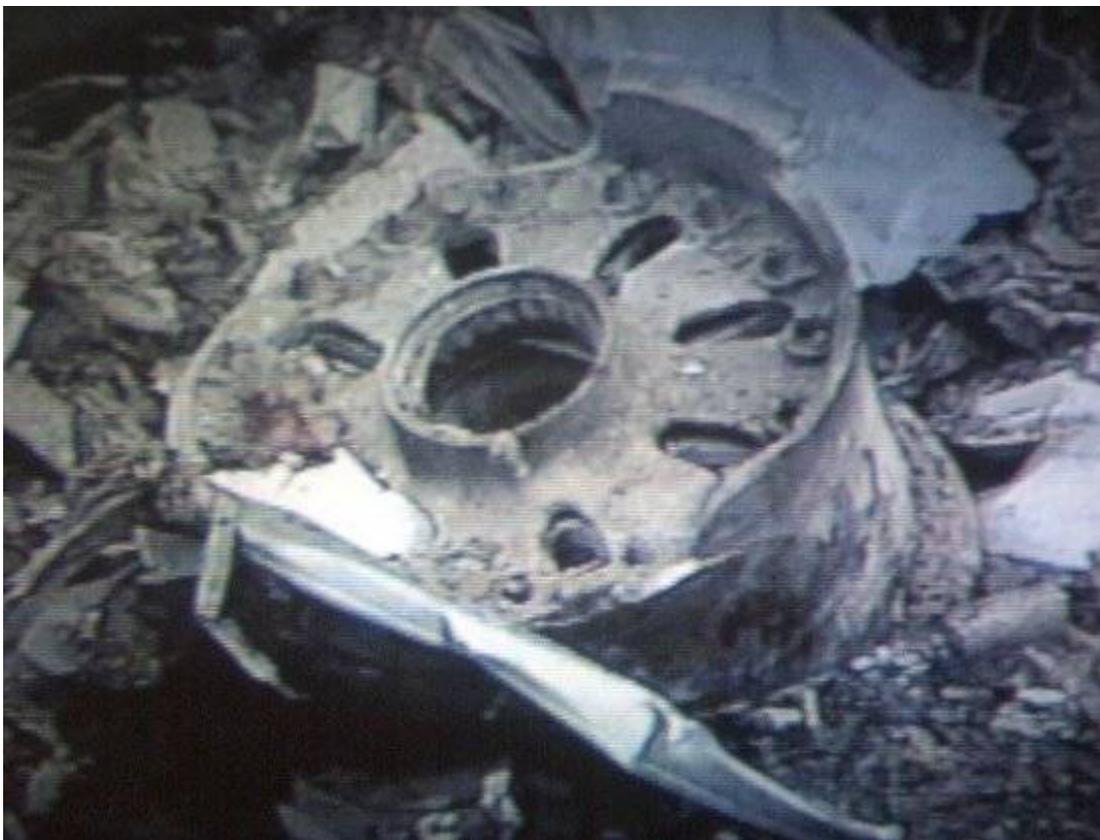
**Close-up view of the Pentagon landing gear wheel**

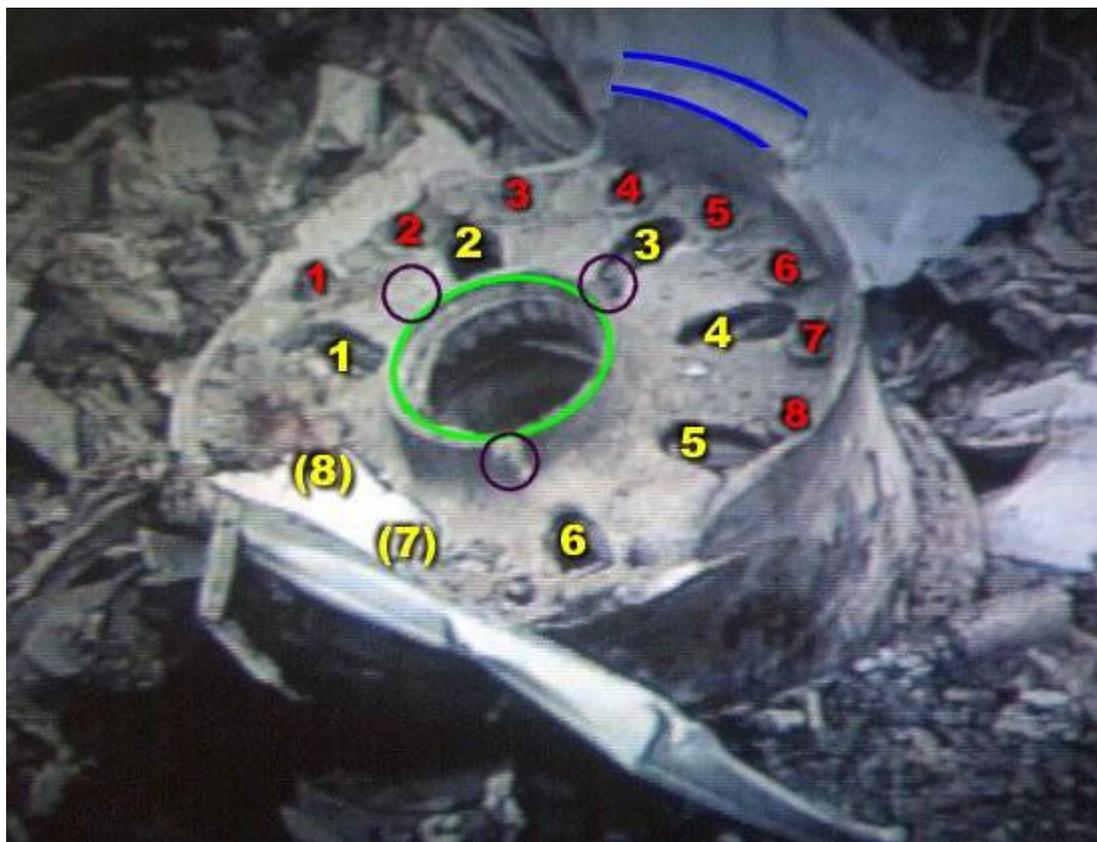
**Key features of the wheel wreckage**

The key features that help to identify the wreckage are further highlighted above. These include:

1. The shape of the rim around the edge, most of which has been destroyed by the violent impact (highlighted in blue)
2. A central hole through which a shaft, or hub, attaches the wheel to the rest of the gear (highlighted in green)
3. Three screw hole projections equally spaced around center hole used to attach a cover over the central hub (highlighted in purple)
4. A series of 16 bolt holes along the edge of the wheel, note that eight holes are visible over half of the wheel while those on the symmetrical half are obscured (numbered in red)
5. Eight oval cutouts, six of which are visible while the final two have been covered by surrounding debris (numbered in yellow)

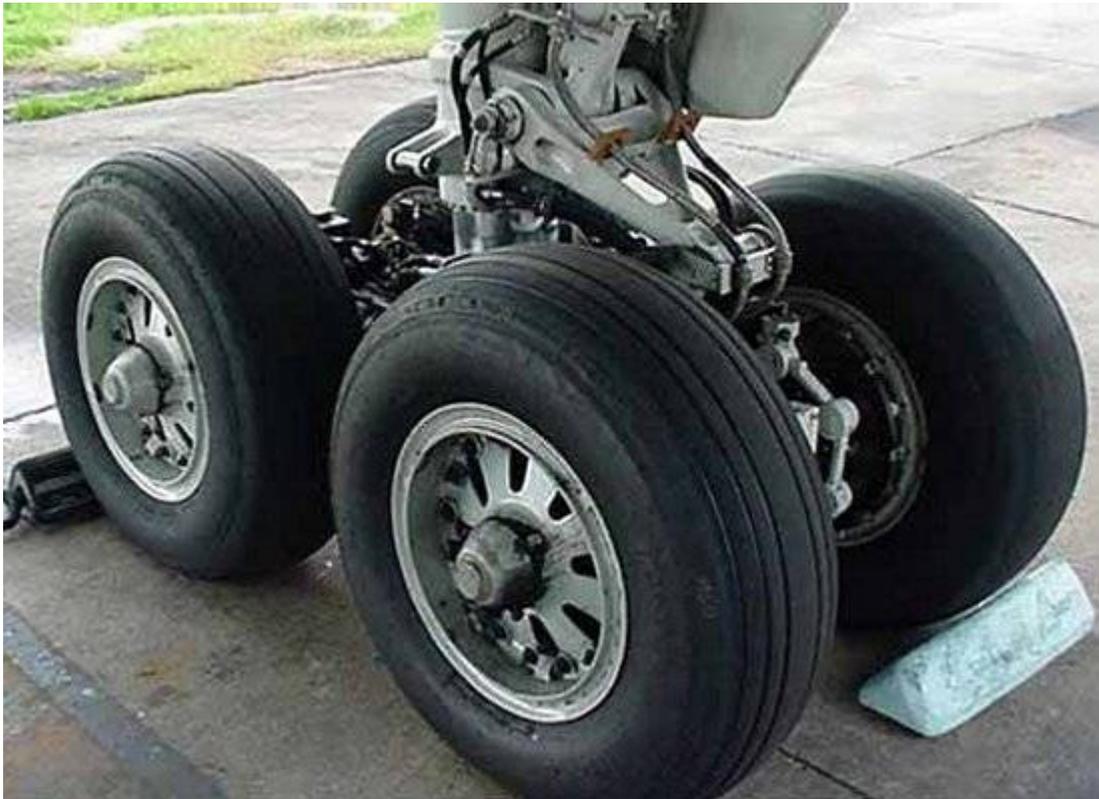
**Boeing 757 main landing gear wheels**

This photo was originally posted on an aviation photography site that has since gone defunct, so we have been unable to determine whom the photographer was or the specific aircraft model it comes from. However, it does appear to be a photo of a Boeing 757. Nevertheless, it is not clear why the author claims this wheel has ten cutouts instead of the eight on the Pentagon debris. Parts of eight equally-spaced cutouts are visible on the closest wheel and it seems unlikely that any additional cutouts are hidden behind the protrusion from the center hub. Perhaps the perception of additional cutouts may be due to the angle at which the photo was taken since the lower corner of the wheel is obscured. A better comparison can be found in the following two pictures that provide a clearer view of the main landing gear wheels on the Boeing 757-200.

"... Government apologists claim the shape of the spokes is the same as that on the 757, and therefore presumably couldn't have come from any other aircraft. Evidently, however, they neglected to notice the fact that the wheel found at the pentagon has only 8 spoke holes, while the wheels used on the pictured 757 have 10. ..."

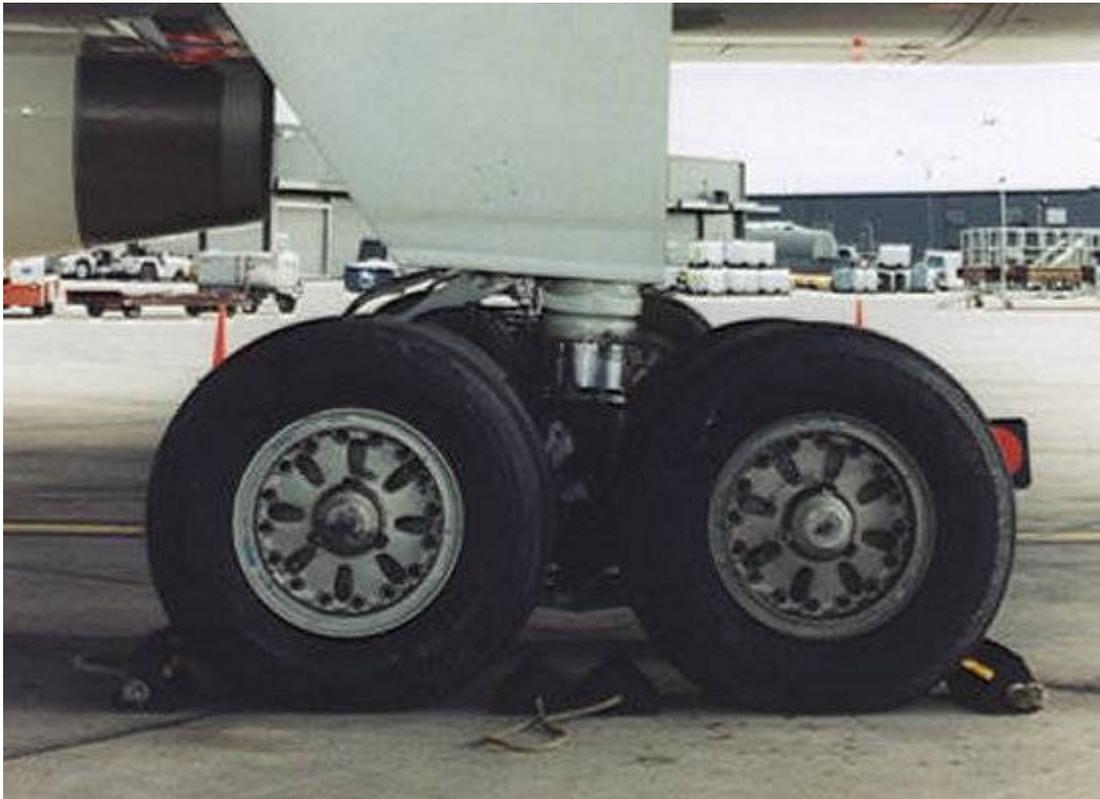
**Boeing 757-200 main landing gear wheels with 8 cutouts**

Both of these aircraft not only have eight cutout holes but also 16 bolt attachment holes, three center screw holes, and an outer rim matching the Pentagon debris in every detail. According to the official story of what happened on September 11, [American Airlines Flight 77](#) was hijacked by five terrorists and crashed into the Pentagon. The aircraft flown on Flight 77 was a Boeing [model number](#) 757-200 with the [registration number](#) N644AA.

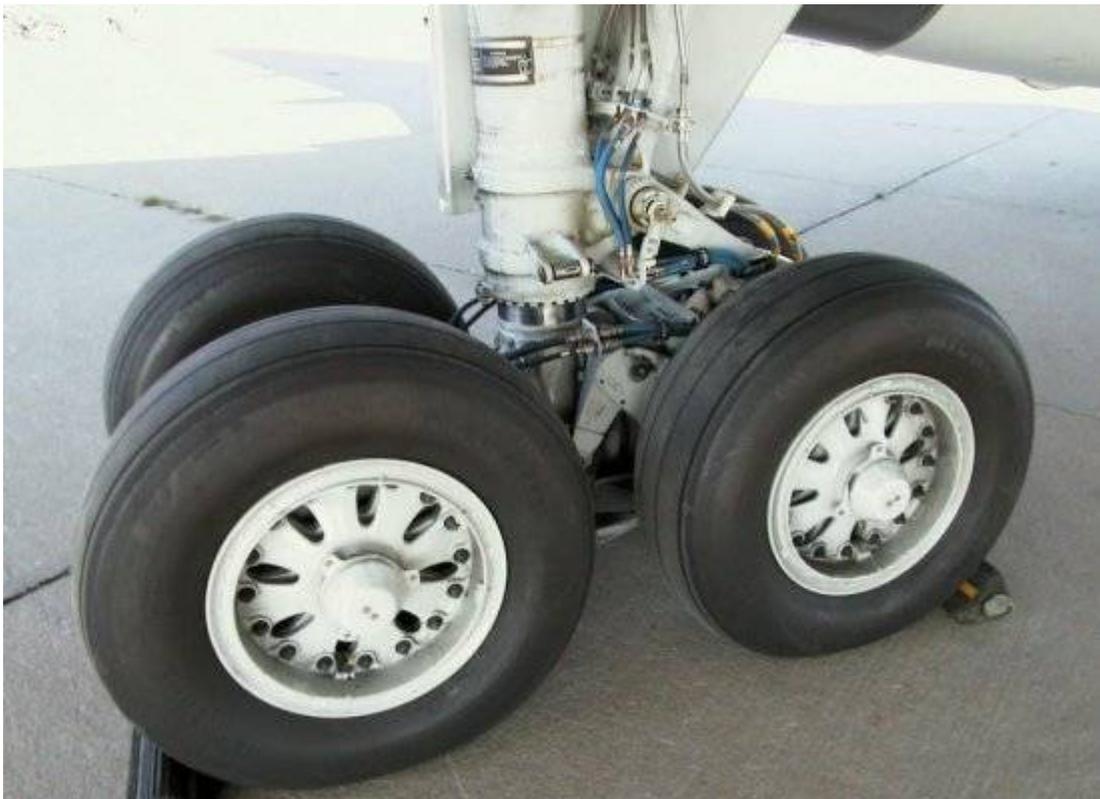
**Boeing 757-200 main landing gear wheels with 8 cutouts**

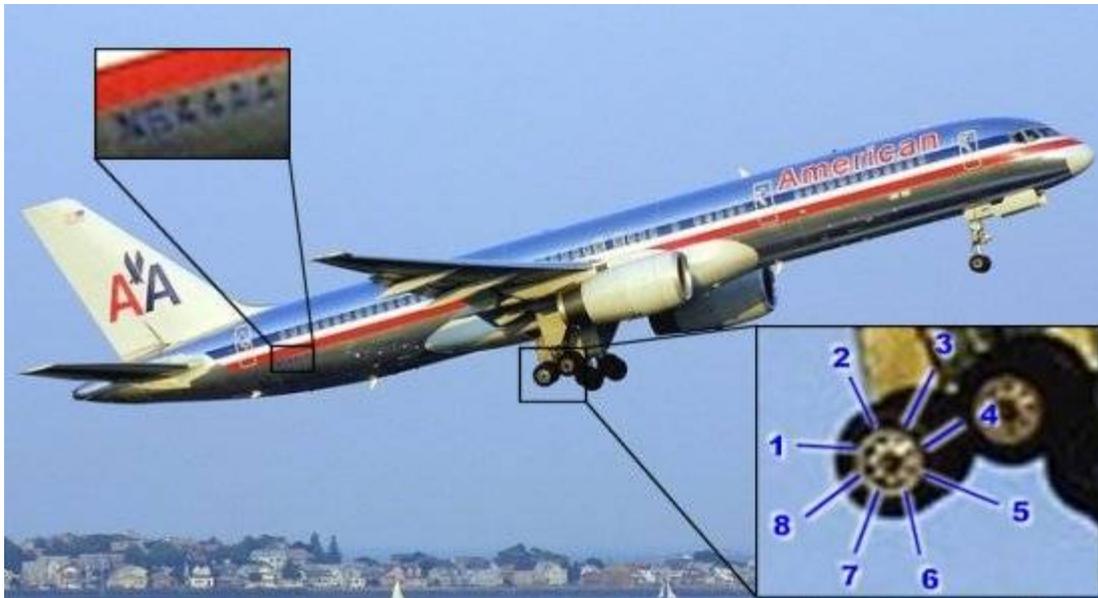
Numerous photos of N644AA were taken while the plane was in service, including the following shot taken just one month before its loss. This picture captures the aircraft shortly after takeoff with its landing gear deployed. Zooming in on the gear, we can see that the main gear wheels of N644AA do indeed have eight cutouts just like the debris found at the Pentagon.

**Boeing 757-200 with tail number N644AA flown on American 77 showing 8 cutouts in its main landing gear wheels**

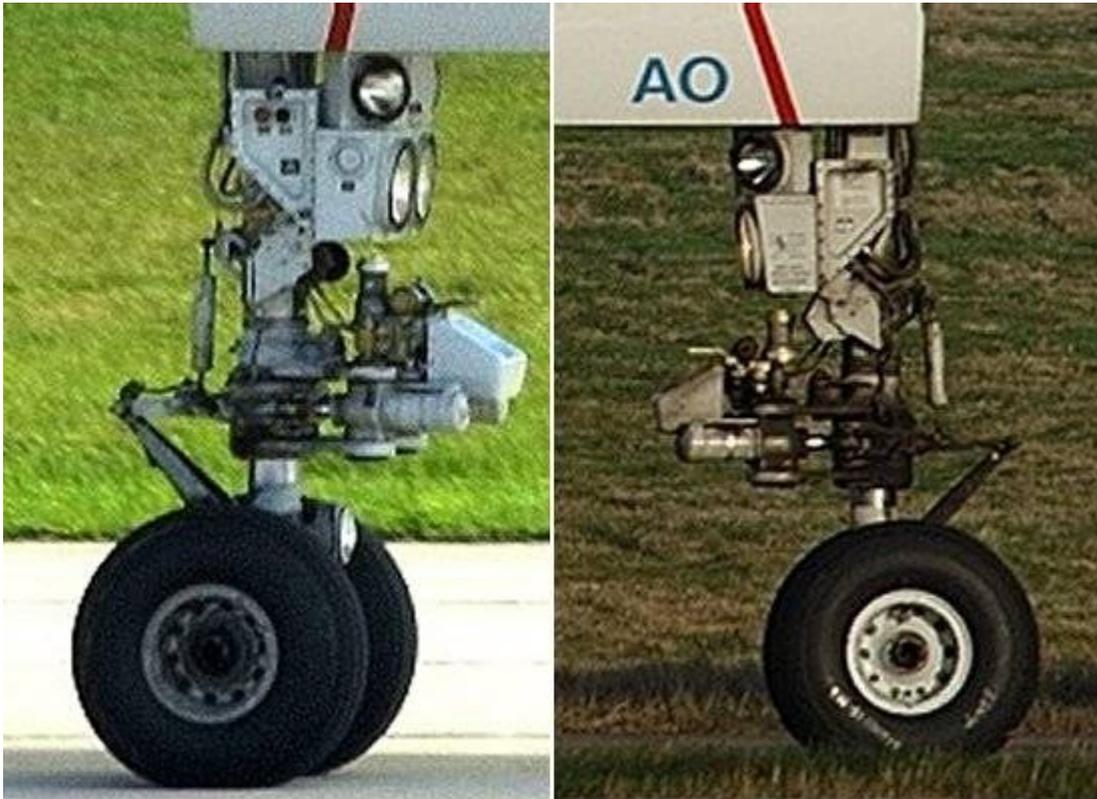
Landing gear wheels of a Boeing 757

If we had no other information to go by and compared these photos to the Pentagon debris, it is easy to see how someone could draw the conclusion that the wreckage is not from a 757. However, this is not an accurate comparison. The previous analysis was based on the 757 main gear while the photos Rhonda provides are obviously nose wheels. Rhonda is correct that these photos do indeed appear to come from a Boeing 757 since they look identical to the following photos taken of 757 nose gear.

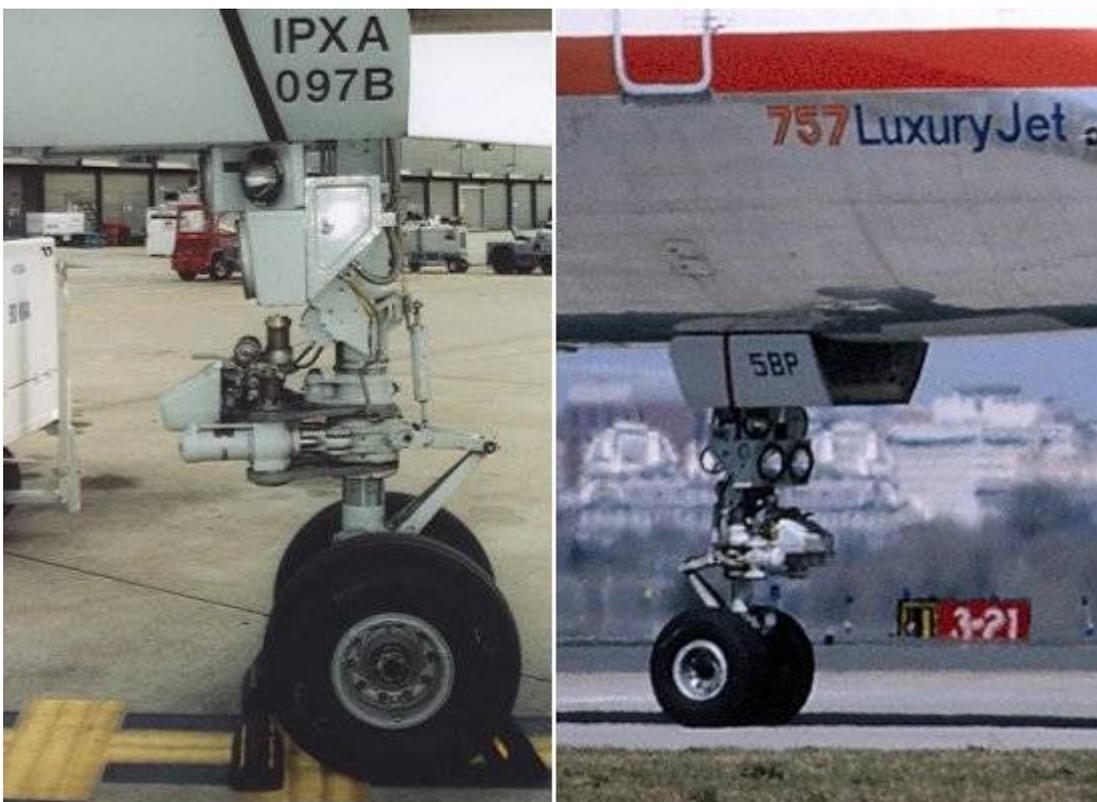
### Boeing 757-200 nose gear wheel

The similarity ends there, however, since the nose wheels are much smaller than their main gear counterparts. The nose wheels also have only ten bolt holes along the perimeter and lack any cutouts like those present on the main wheels. Drawing a conclusion about whether a 757 actually struck the Pentagon based on the wrong 757 wheel is clearly a false comparison and does nothing to detract from the official government investigation or to support the various conspiracy opinions.

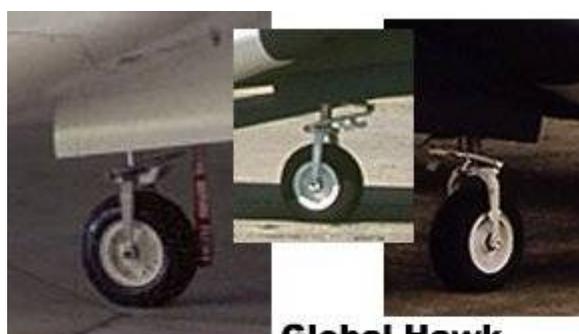
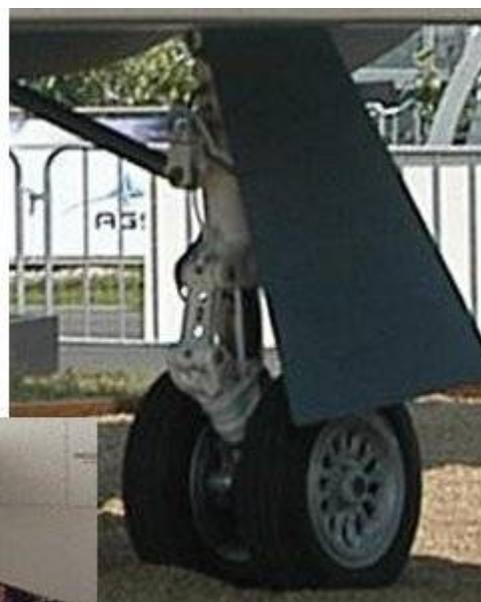
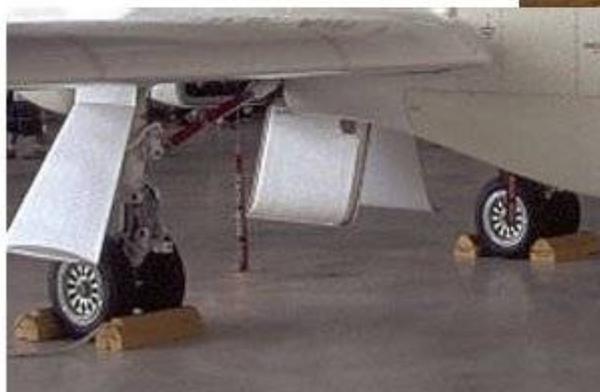
**Global Hawk  
Nose Gear Wheel**

**Global Hawk  
Main Gear Wheels**

**Main and nose gear wheels of Global Hawk**

Numerous photos of the vehicle are available in print and on-line sources including views of its landing gear. The above pictures show close-ups of the Global Hawk's main and nose gear wheels. These images confirm that the Global Hawk wheels look considerably different than those of the 757 and do not match any of the key details of the Pentagon debris. Most noticeable is the fact that the Global Hawk's main gear wheels have twelve cutouts rather than the eight present on a 757. The shape of the cutouts is also considerably narrower and more elongated than those visible in the Pentagon wreckage.

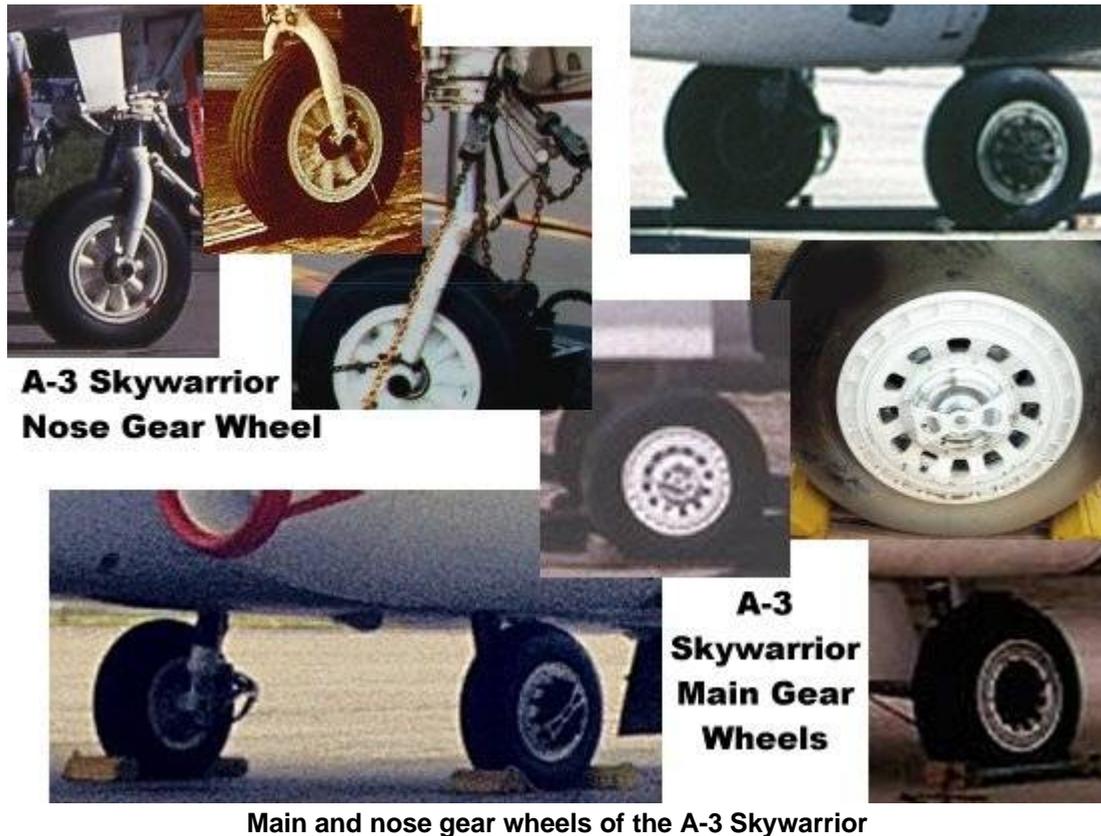
Clearly, these wheels are of a considerably different design than those of the 757. Of particular interest is the shape of the main wheel which has a smaller rim, twelve cutouts that are of a rectangular shape and far smaller than those on the 757, and an inner rim around the center of the wheel unlike anything seen on the Pentagon wreckage. Several of the A-3 photos also show a hubcap that again does not match anything on a 757 wheel or the Pentagon debris.

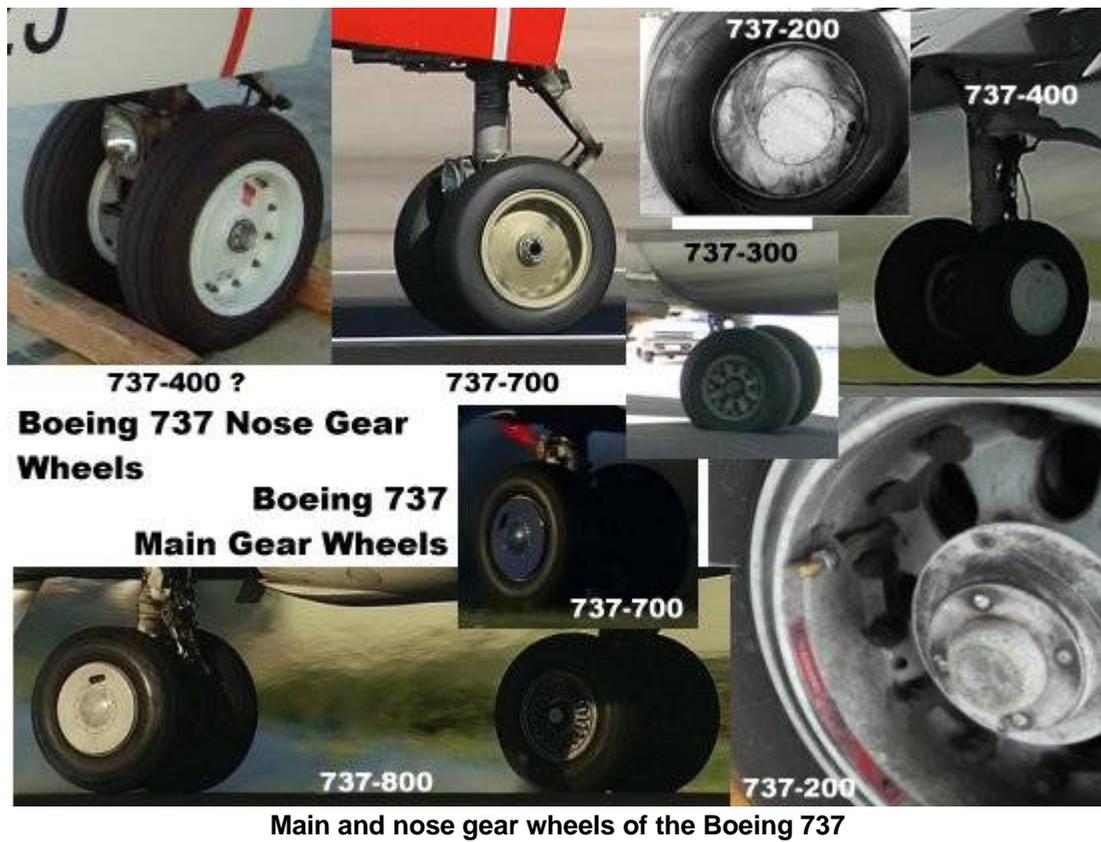
Main and nose gear wheels of the Boeing 737

Although the investigation is complicated by the presence of a hubcap used on the outboard main gear, it is apparent that none of these designs matches that found on the Pentagon wheel. The closest match is the 737-200 main gear wheel shown in the lower right corner. This wheel appears to share eight cutouts and 16 bolt holes along the circumference like that found in the wreckage. However, the shape of the cutouts is much more circular and the region around the central hub is completely different. None of the 737 wheels are a good match for the Pentagon wheel.

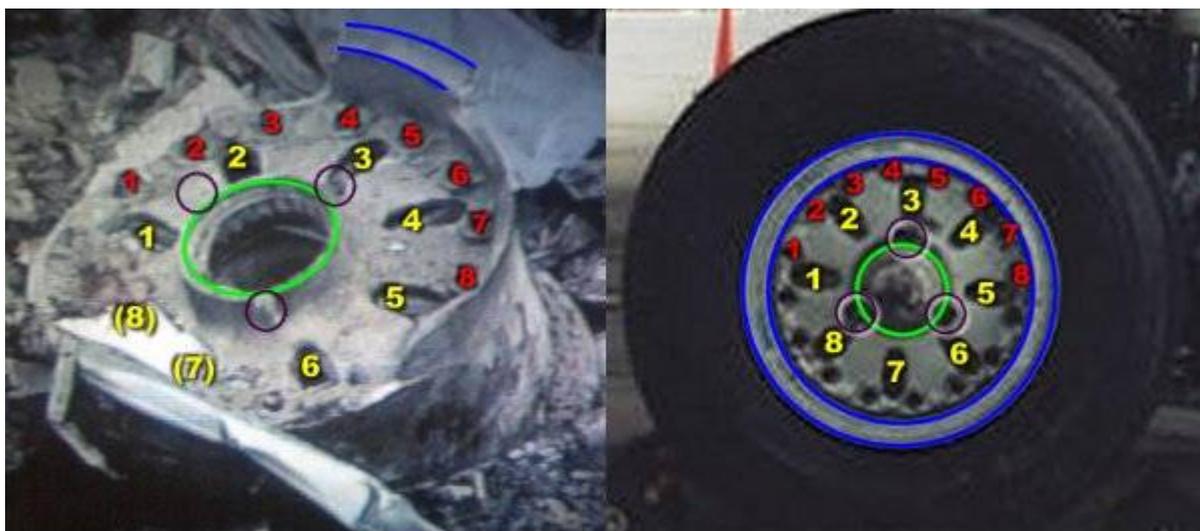
**Pentagon Wheel Wreckage**

**Boeing 757-200  
Main Landing Gear Wheel**

Comparison of the Pentagon wreckage to a Boeing 757-200 main gear wheel

key features of the wreckage--including the number, size, and shape of the cutouts and bolt attachments--perfectly match those found in a main landing gear wheel of a Boeing 757-200, as illustrated in the above comparison. None of the wheels of the Global Hawk, A-3, or 737 match the debris, which is not surprising since all of these aircraft weigh considerably less than the 757 and use correspondingly smaller wheels of differing design.
