Pentagon & Boeing 757 Wheel Investigation

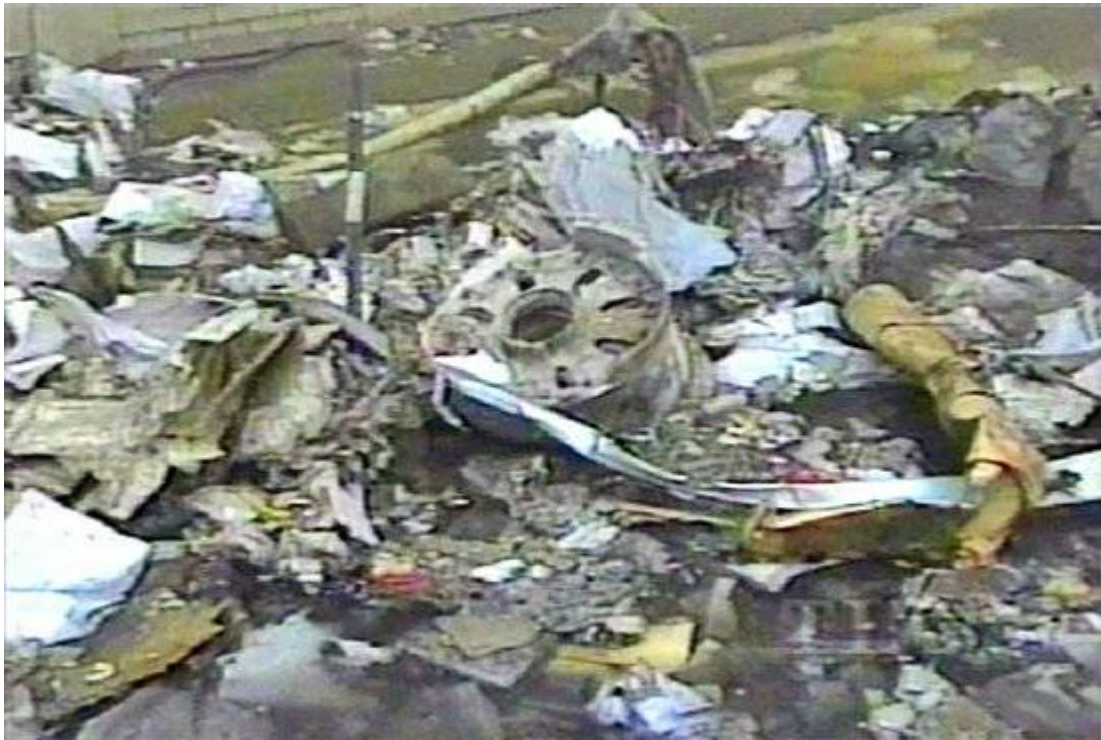
Landing gear wheel visible at the Pentagon

The above photo was taken at the Pentagon after the September 11 attack and contains a clearly identifiable piece of landing gear wreckage from the aircraft that impacted the building. A closer view of the item, shown below, reveals additional detail in the shape of this landing gear component.

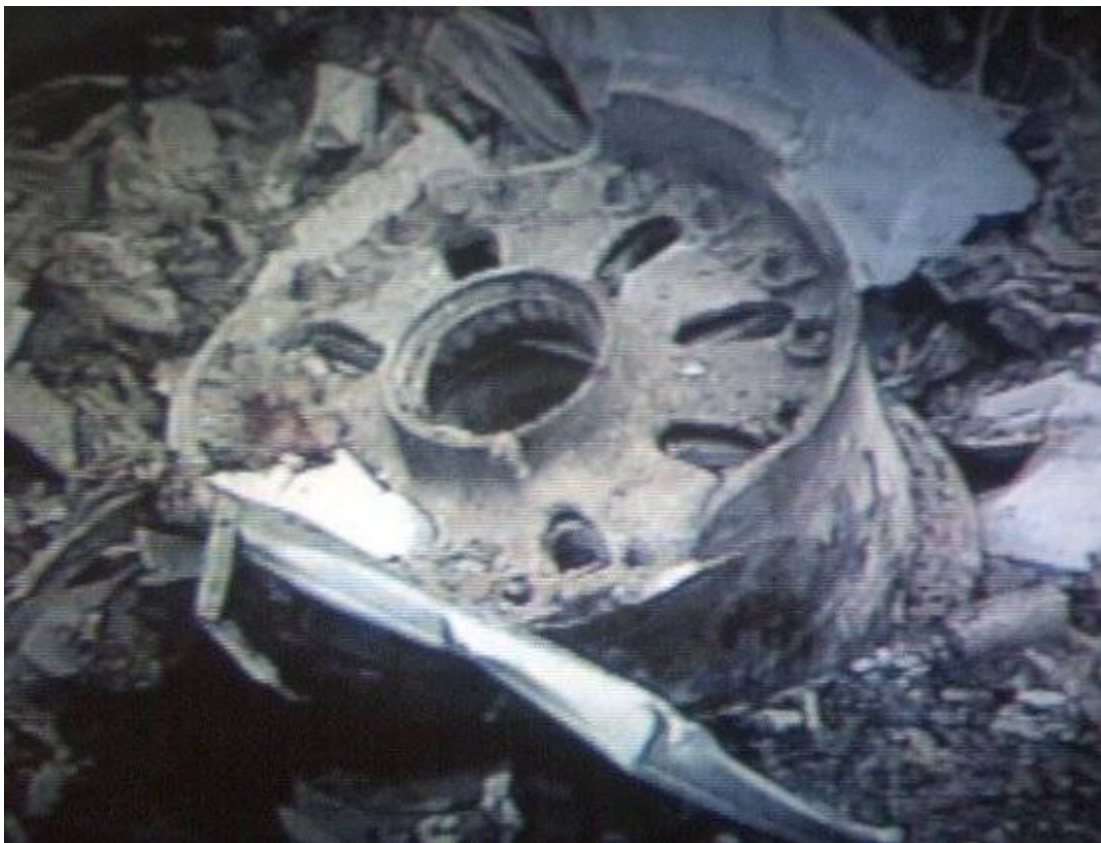
Close-up view of the Pentagon landing gear wheel

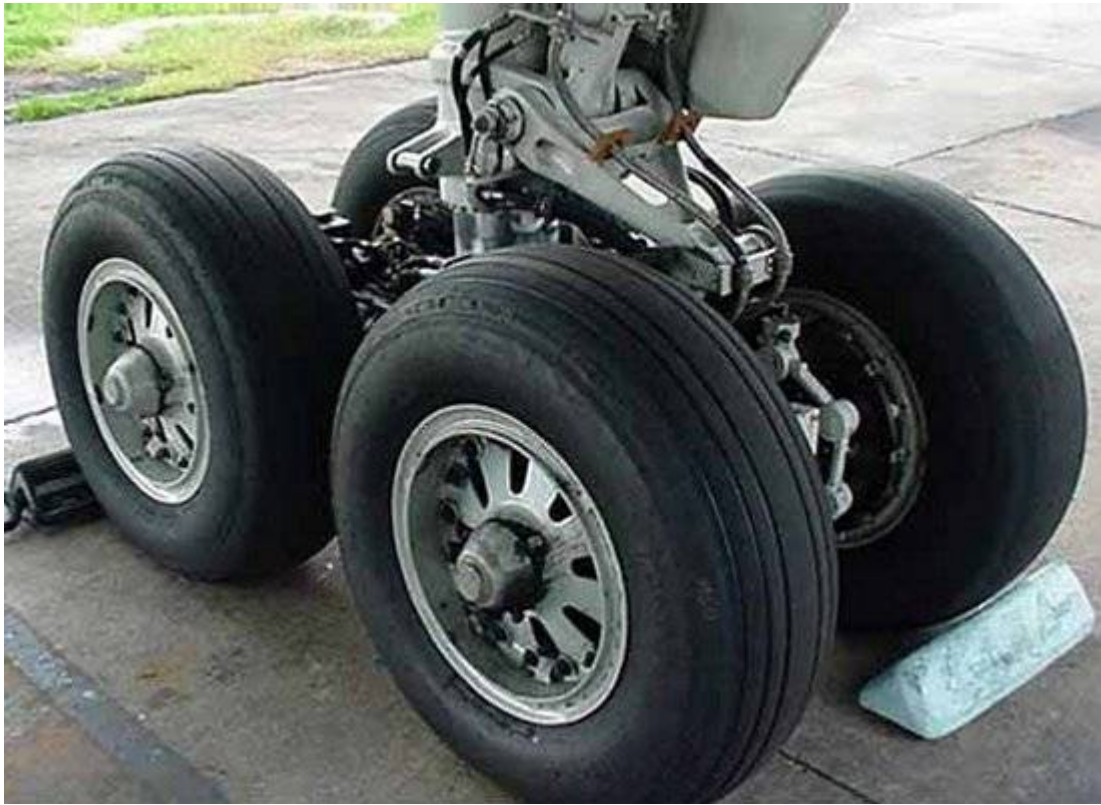
Boeing 757 main landing gear wheels

This photo was originally posted on an aviation photography site that has since gone defunct, so we have been unable to determine whom the photographer was or the specific aircraft model it comes from. However, it does appear to be a photo of a Boeing 757. Nevertheless, it is not clear why the author claims this wheel has ten cutouts instead of the eight on the Pentagon debris. Parts of eight equally-spaced cutouts are visible on the closest wheel and it seems unlikely that any additional cutouts are hidden behind the protrusion from the center hub. Perhaps the perception of additional cutouts may be due to the angle at which the photo was taken since the lower corner of the wheel is obscured. A better comparison can be found in the following two pictures that provide a clearer view of the main landing gear wheels on the Boeing 757-200.

"... Government apologists claim the shape of the spokes is the same as that on the 757, and therefore presumably couldn't have come from any other aircraft. Evidently, however, they neglected to notice the fact that the wheel found at the pentagon has only 8 spoke holes, while the wheels used on the pictured 757 have 10. ..."

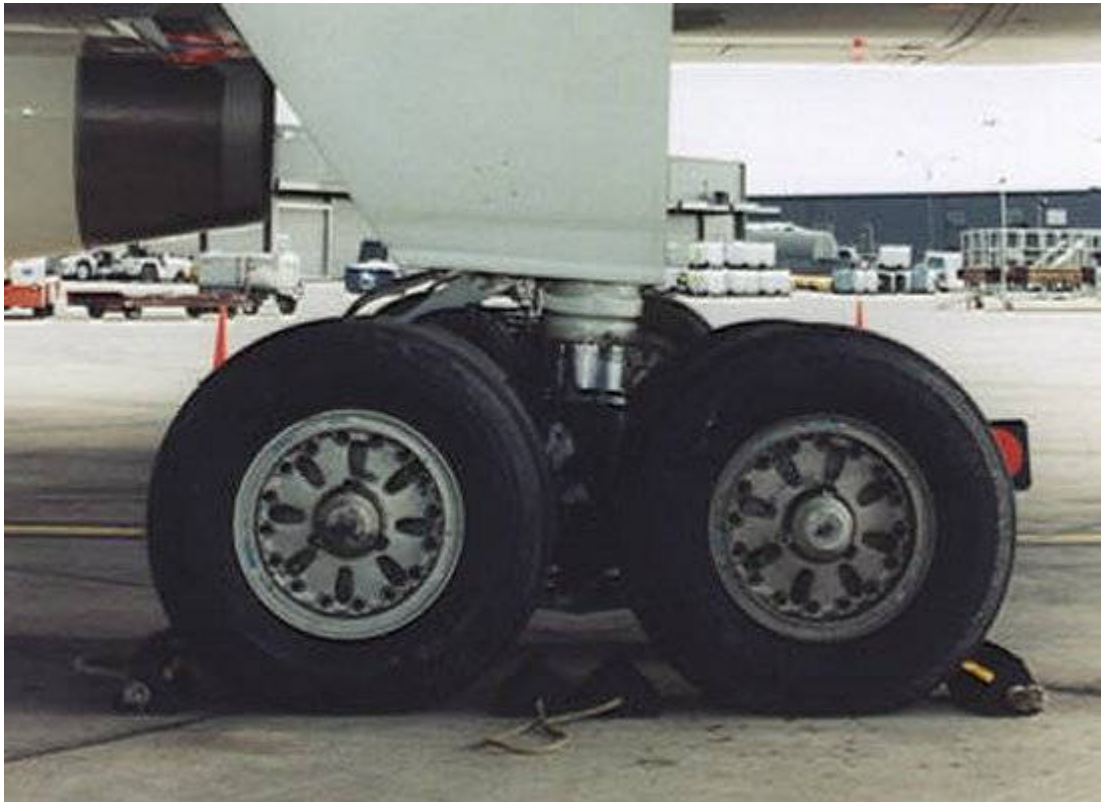
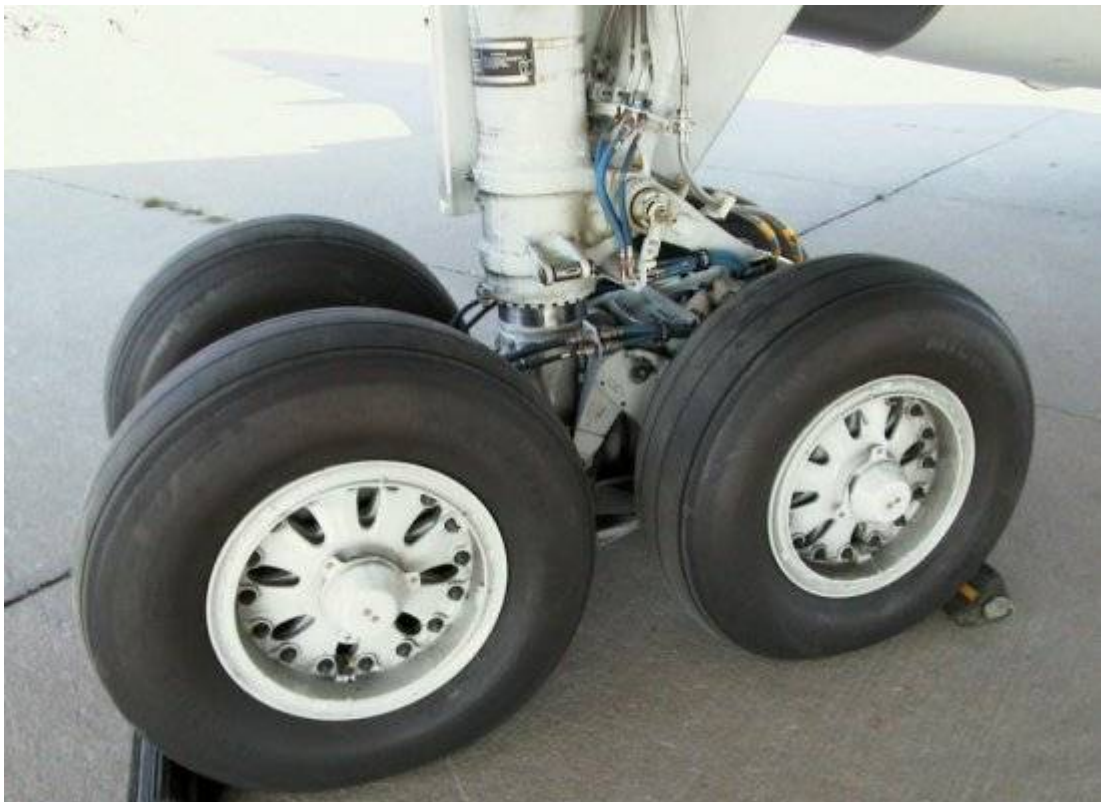
Boeing 757-200 main landing gear wheels with 8 cutouts

Both of these aircraft not only have eight cutout holes but also 16 bolt attachment holes, three center screw holes, and an outer rim matching the Pentagon debris in every detail. According to the official story of what happened on September 11, [American Airlines Flight 77](#) was hijacked by five terrorists and crashed into the Pentagon. The aircraft flown on Flight 77 was a Boeing [model number](#) 757-200 with the [registration number](#) N644AA.

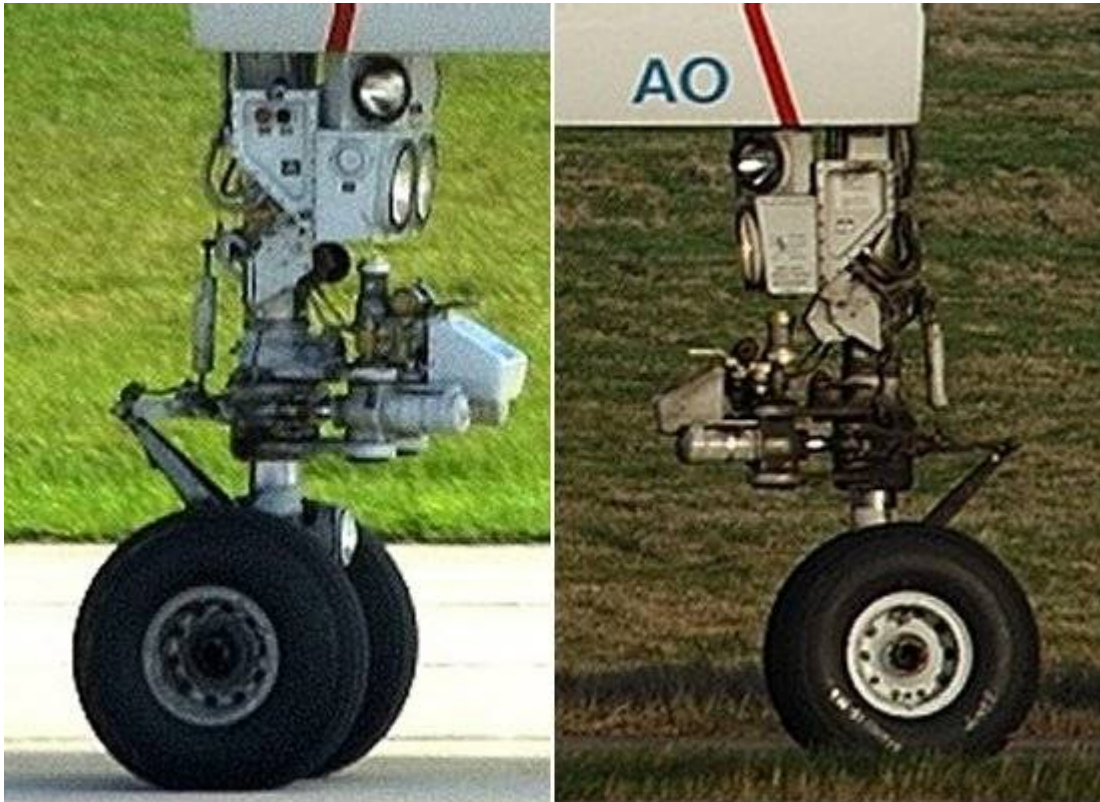
Landing gear wheels of a Boeing 757

If we had no other information to go by and compared these photos to the Pentagon debris, it is easy to see how someone could draw the conclusion that the wreckage is not from a 757. However, this is not an accurate comparison. The previous analysis was based on the 757 main gear while the photos Rhonda provides are obviously nose wheels. Rhonda is correct that these photos do indeed appear to come from a Boeing 757 since they look identical to the following photos taken of 757 nose gear.

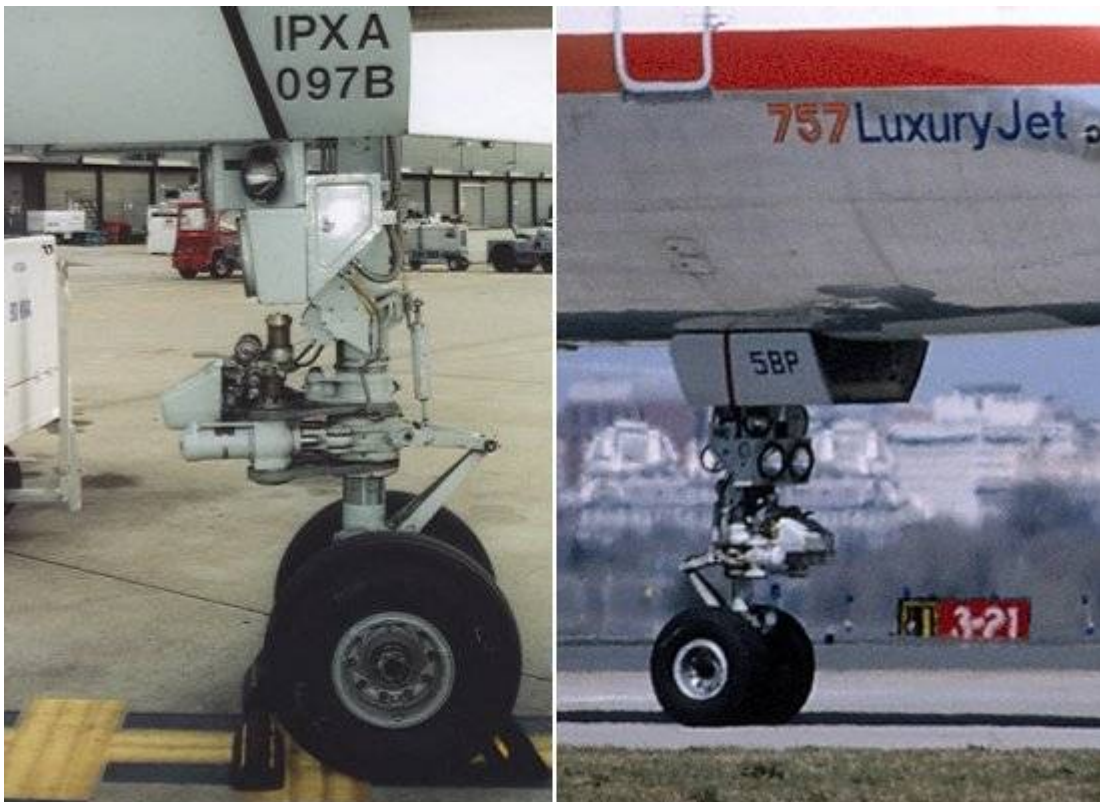
Boeing 757-200 nose gear wheel

The similarity ends there, however, since the nose wheels are much smaller than their main gear counterparts. The nose wheels also have only ten bolt holes along the perimeter and lack any cutouts like those present on the main wheels. Drawing a conclusion about whether a 757 actually struck the Pentagon based on the wrong 757 wheel is clearly a false comparison and does nothing to detract from the official government investigation or to support the various conspiracy opinions.

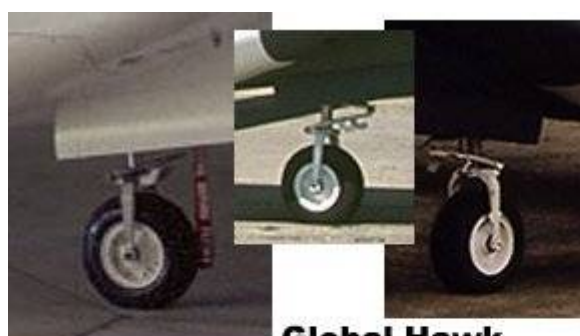
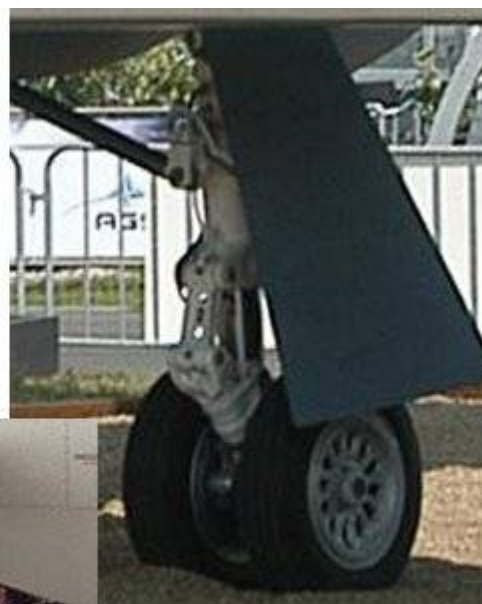
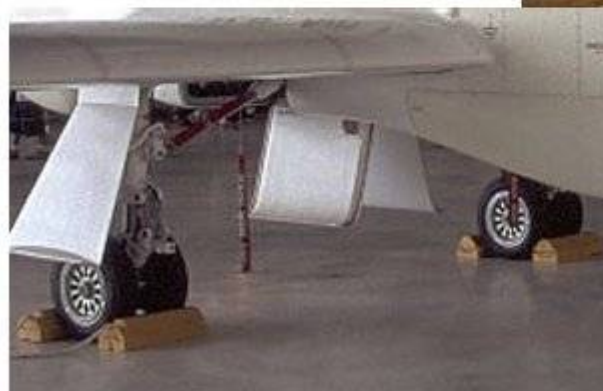
**Global Hawk
Nose Gear Wheel**

**Global Hawk
Main Gear Wheels**

Main and nose gear wheels of Global Hawk

Numerous photos of the vehicle are available in print and on-line sources including views of its landing gear. The above pictures show close-ups of the Global Hawk's main and nose gear wheels. These images confirm that the Global Hawk wheels look considerably different than those of the 757 and do not match any of the key details of the Pentagon debris. Most noticeable is the fact that the Global Hawk's main gear wheels have twelve cutouts rather than the eight present on a 757. The shape of the cutouts is also considerably narrower and more elongated than those visible in the Pentagon wreckage.

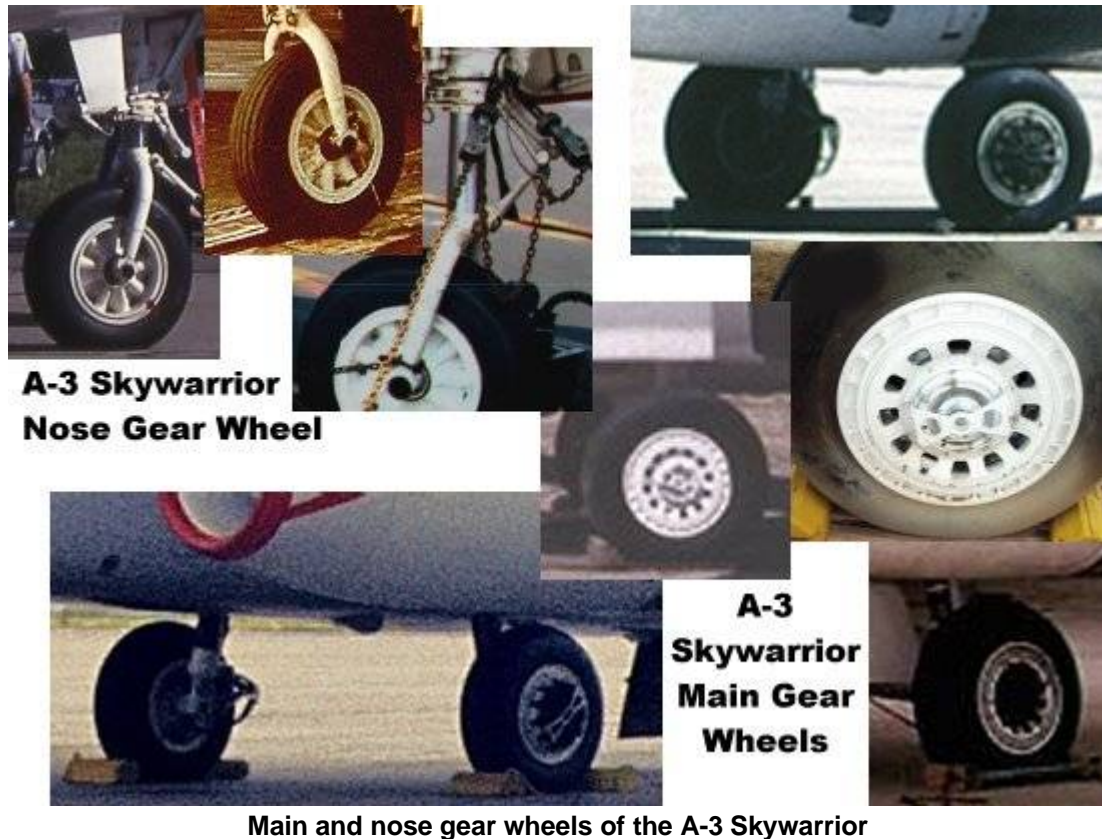
Clearly, these wheels are of a considerably different design than those of the 757. Of particular interest is the shape of the main wheel which has a smaller rim, twelve cutouts that are of a rectangular shape and far smaller than those on the 757, and an inner rim around the center of the wheel unlike anything seen on the Pentagon wreckage. Several of the A-3 photos also show a hubcap that again does not match anything on a 757 wheel or the Pentagon debris.

Another popular theory states that an A-3 Skywarrior was the type of aircraft used to attack the Pentagon. Built by Douglas Aircraft during the 1950s, the Skywarrior was a US Navy aircraft used for heavy attack and airborne jamming missions. The A-3 is obsolete, has been retired for decades, and very few remain in a flyable condition. The following is a collection of pictures of the Skywarrior's nose and main landing gear wheels for comparison

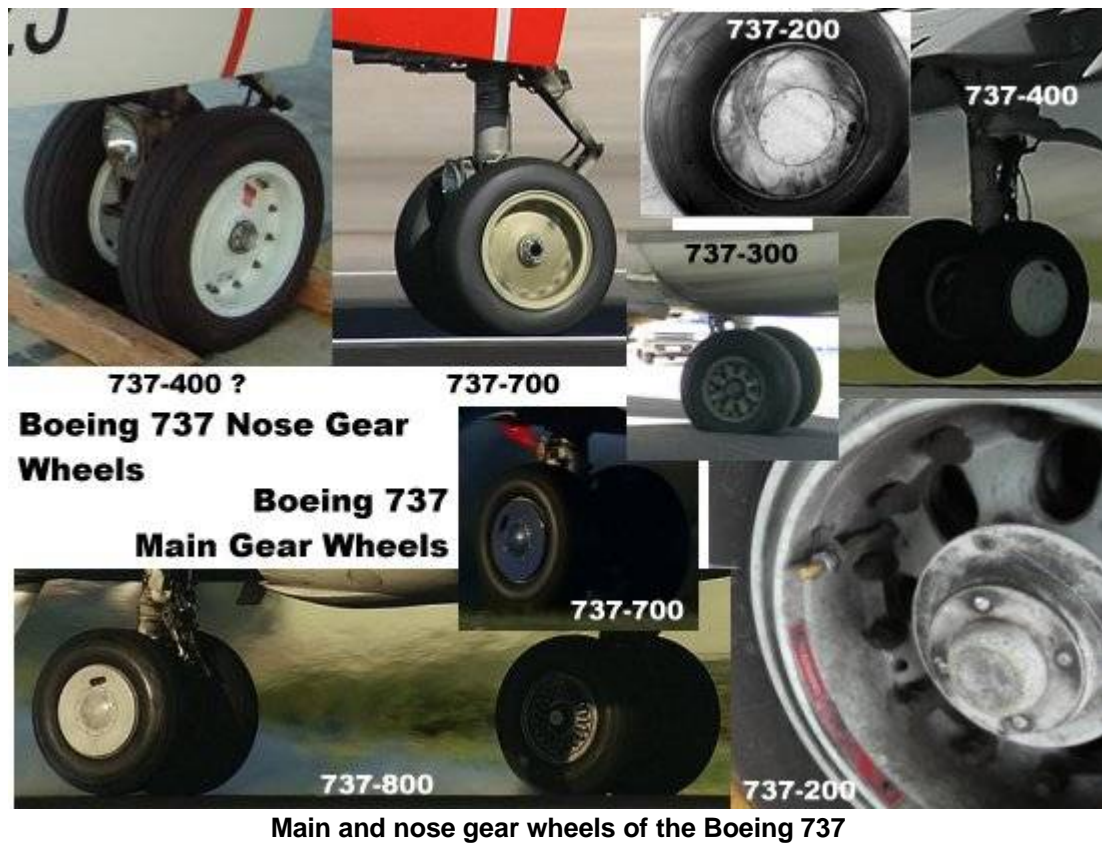
Main and nose gear wheels of the Boeing 737

Although the investigation is complicated by the presence of a hubcap used on the outboard main gear, it is apparent that none of these designs matches that found on the Pentagon wheel. The closest match is the 737-200 main gear wheel shown in the lower right corner. This wheel appears to share eight cutouts and 16 bolt holes along the circumference like that found in the wreckage. However, the shape of the cutouts is much more circular and the region around the central hub is completely different. None of the 737 wheels are a good match for the Pentagon wheel.
