Pentagon & Boeing 757 Engine Investigation

I've seen pictures of engine wreckage at the Pentagon after 9/11. Your site says the engine of a 757 is over 6 feet across but this piece is way smaller than that. Does it prove that whatever hit the Pentagon was not a 757 and the government is lying about it?

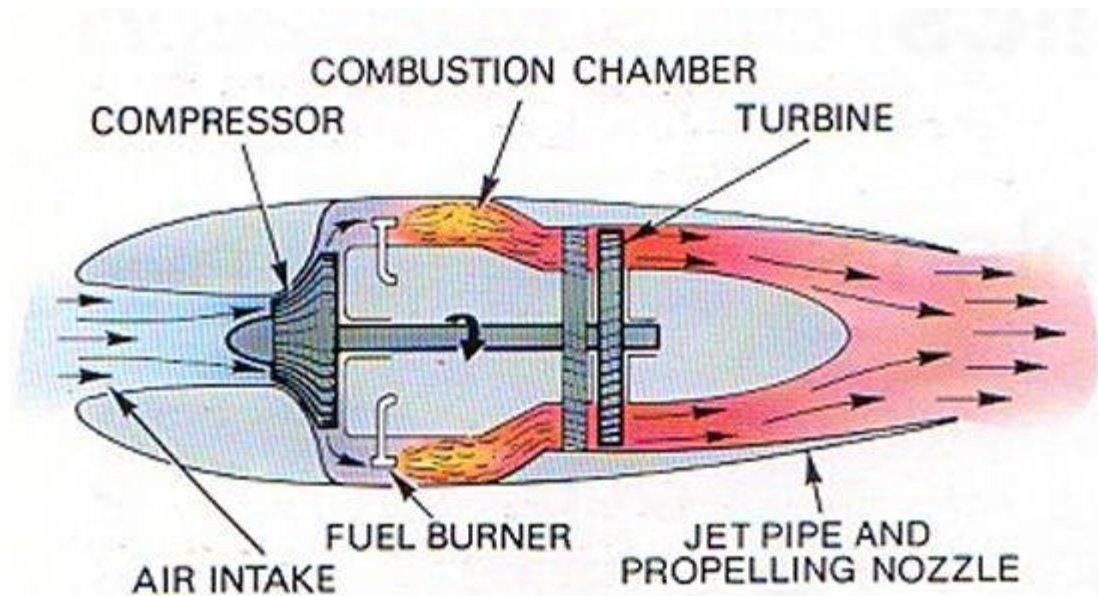
Schematic of a simple jet engine

In order to better understand the parts of a jet engine and how this form of propulsion works, let us briefly revisit the different [types of jet engines](#). The earliest form of jet propulsion was the [turbojet](#). This type of powerplant employs a series of compressor blades mounted on rotating disks that squeeze incoming air to a higher pressure and temperature. The compressed air is then mixed with fuel and ignited. The high temperature air passes through another series of rotating blades called a turbine, which causes this turbine to spin. The turbine rotors are attached to a central shaft running the length of the engine, so the turbine's spinning motion causes this shaft to rotate as well. Also attached to the same central shaft is the compressor section at the front of the engine. This connection between the turbine and compressor sections causes the compressor stages to continue spinning, bringing in additional air to keep the engine functioning in a repeating cycle. Once the airflow moves past the turbines, it is exhausted through a nozzle. The expansion of the high pressure gases against the nozzle walls creates thrust that pushes the engine forward, as well as the vehicle it is attached to.

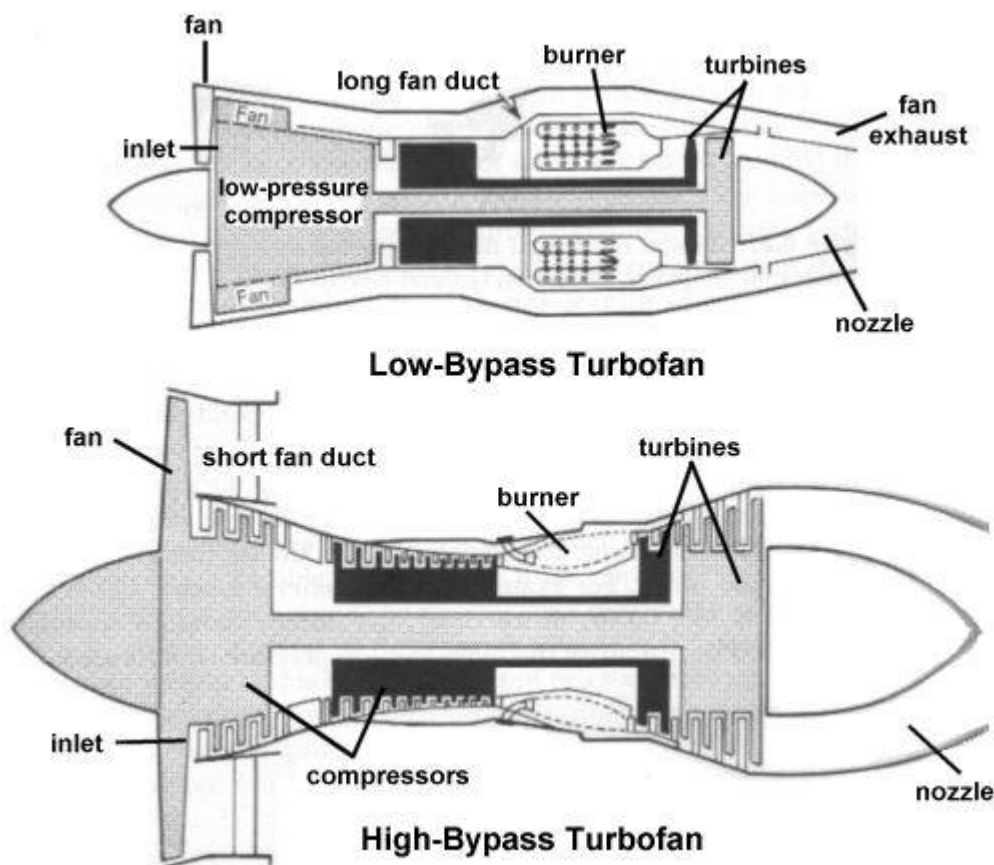
Comparison of a low-bypass turbofan with long ducts and a high-bypass turbofan with short ducts

As shown in the above diagram, a turbofan contains many rotating compressor and turbine disks, all of which are smaller than the fan at the front of the engine. The rotary components within a high-bypass turbofan, in particular, are often only a small fraction of the fan diameter. Most specifications describing the overall size of an engine will list the fan diameter since this measurement defines the engine's maximum width. Our earlier article about the 757 uses this dimension to compare the diameter of the engine nacelle to that of the fuselage.

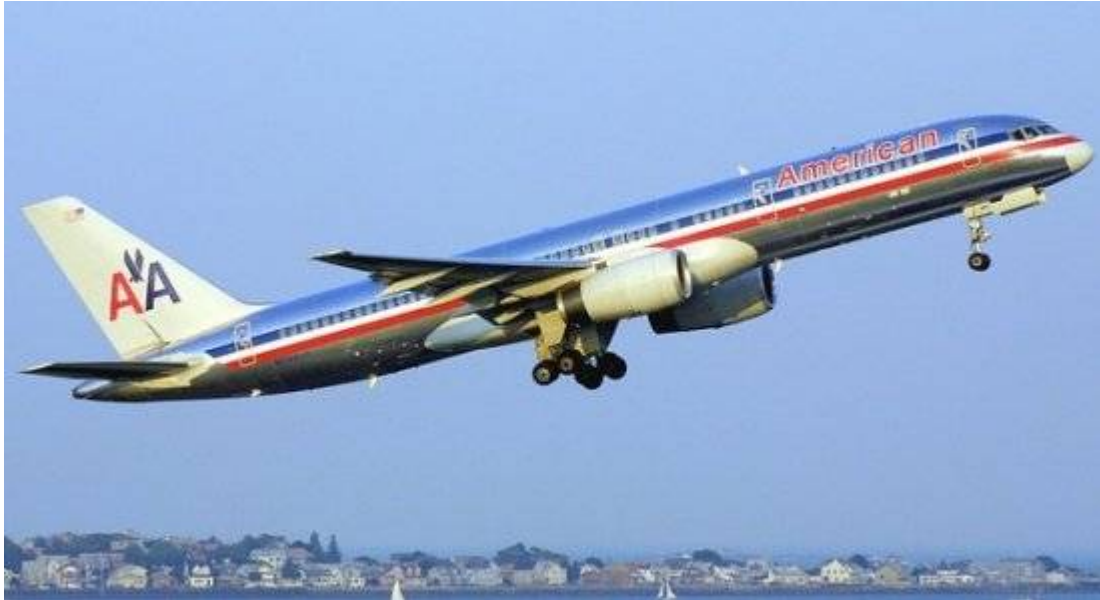
American Airlines Boeing 757-200 with tail number N644AA

According to the accepted story, American Airlines Flight 77 was hijacked by five al Qaeda terrorists as it was traveling from Washington DC to Los Angeles. The aircraft involved in this hijacking was a Boeing Model 757-200 with the [Boeing customer code](#) 757-223 and the [registration number](#) N644AA. This same aircraft is pictured above in a photo taken at Logan International Airport in Boston on 7 August 2001. The terrorists steered the plane into the west side of the Pentagon killing 59 passengers and crew as well as 125 victims on the ground.

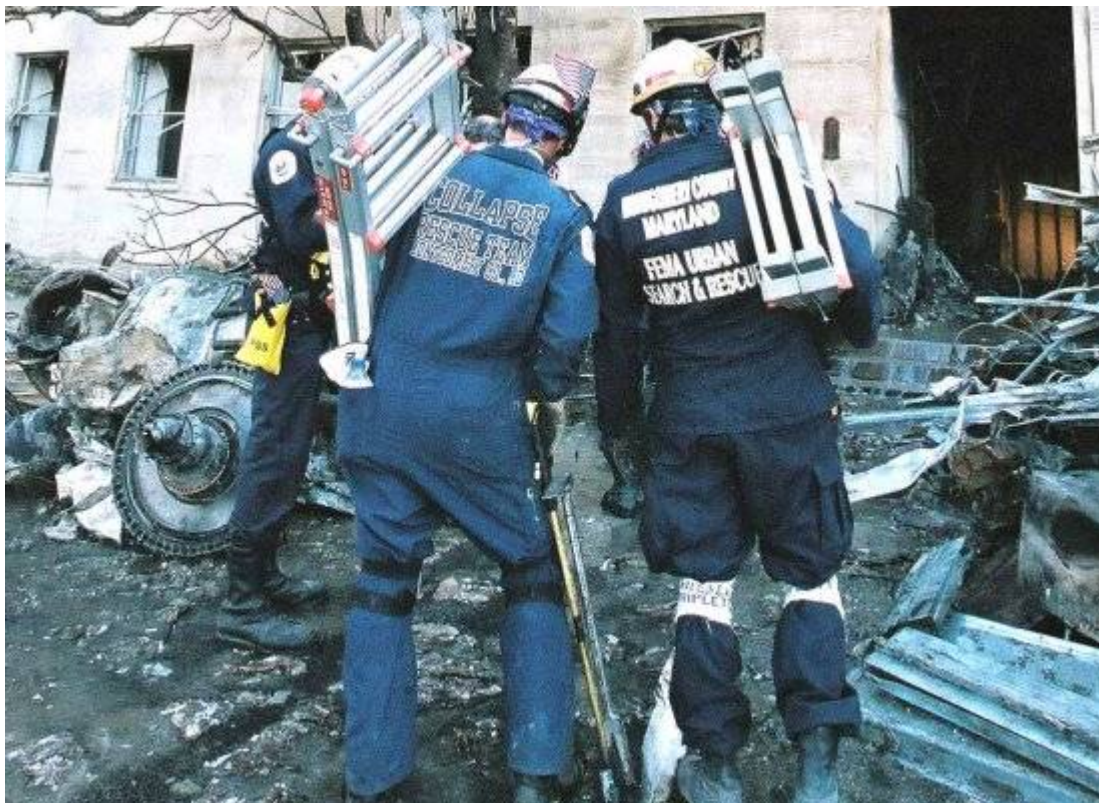
Those who doubt this version of events point to wreckage at the Pentagon as proof that some other kind of aircraft or missile was actually responsible for the attack. Probably the one piece of debris that has prompted the most debate is the following photo of what looks like a rotary disk from the interior of the plane's engine. This disk could be part of a fan, a compressor, or a turbine rotor from inside the engine, but the blades are not present and were presumably knocked off in the impact.

Rotating engine disk visible at the Pentagon

Based on the sizes of the person standing next to the debris and other objects in the photographs that we can use for comparison, it has been estimated that the disk is approximately 25 to 30 inches (63.5 to 76.2 cm) across. Obviously, this piece is far smaller than the maximum engine diameter of 6 feet (1.8 m) or more leading many to draw the conclusion that the item is not from a 757 engine. That conjecture causes conspiracy theorists to believe that a much smaller vehicle must have struck the Pentagon instead.

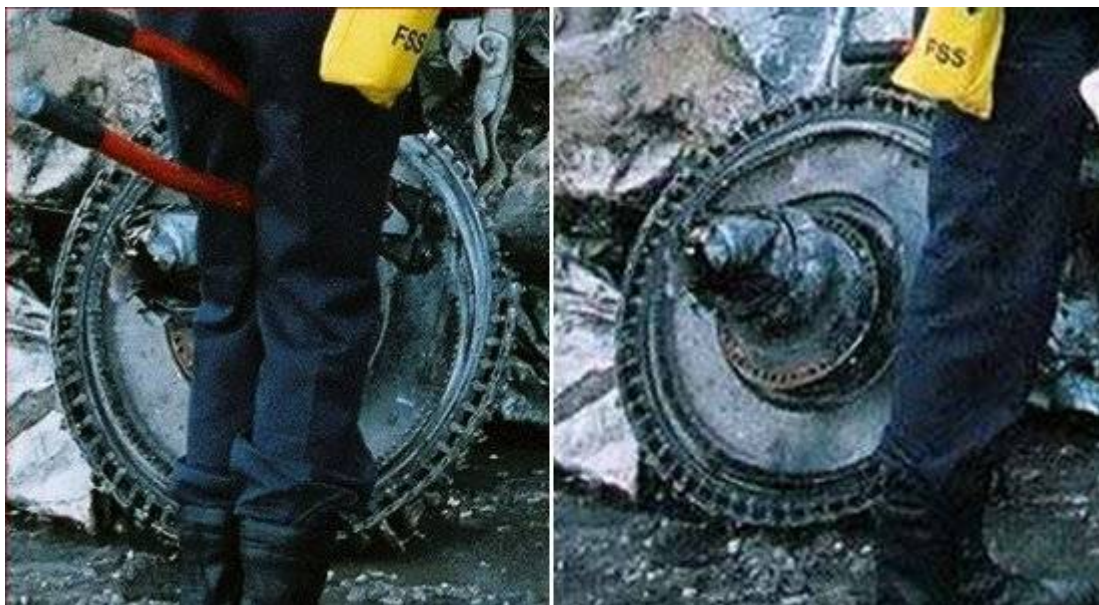
Close-up views of the Pentagon engine component

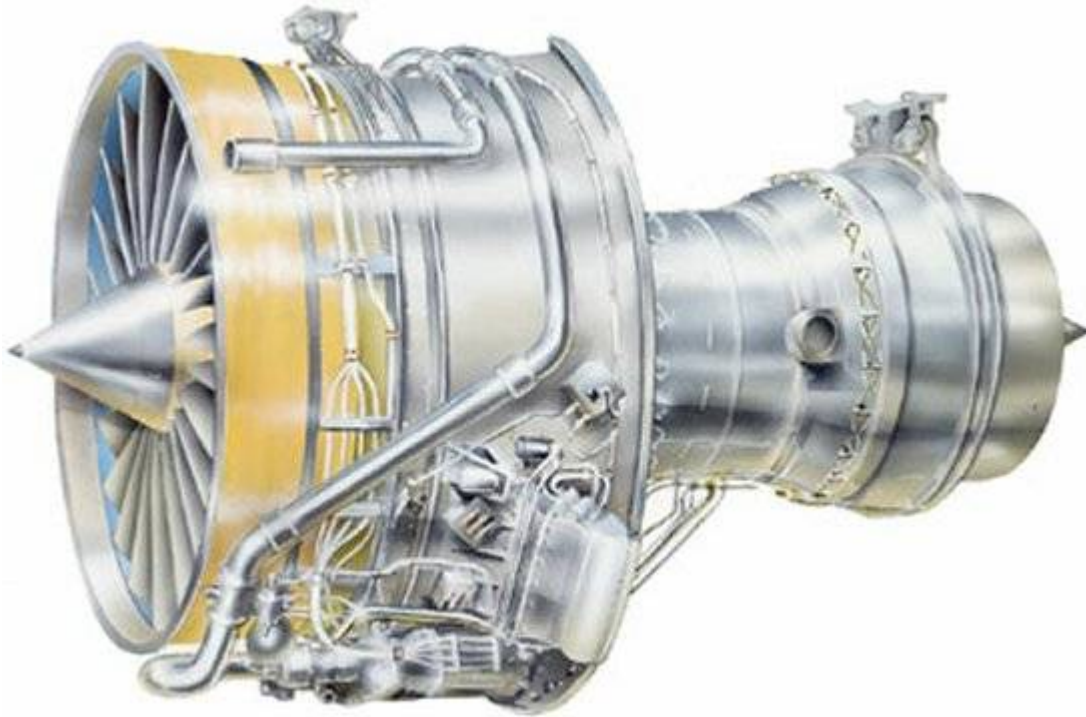
Diagram of the Rolls-Royce RB211-535 turbofan

Note the relative sizes of the forward portion of this engine compared to the central core. Clearly, the section housing the fan is much wider than the turbojet core that contains the compressor and turbine components. We can get a clearer view of the relative sizes of components within this engine in the following cut-away drawing of the RB211-535.

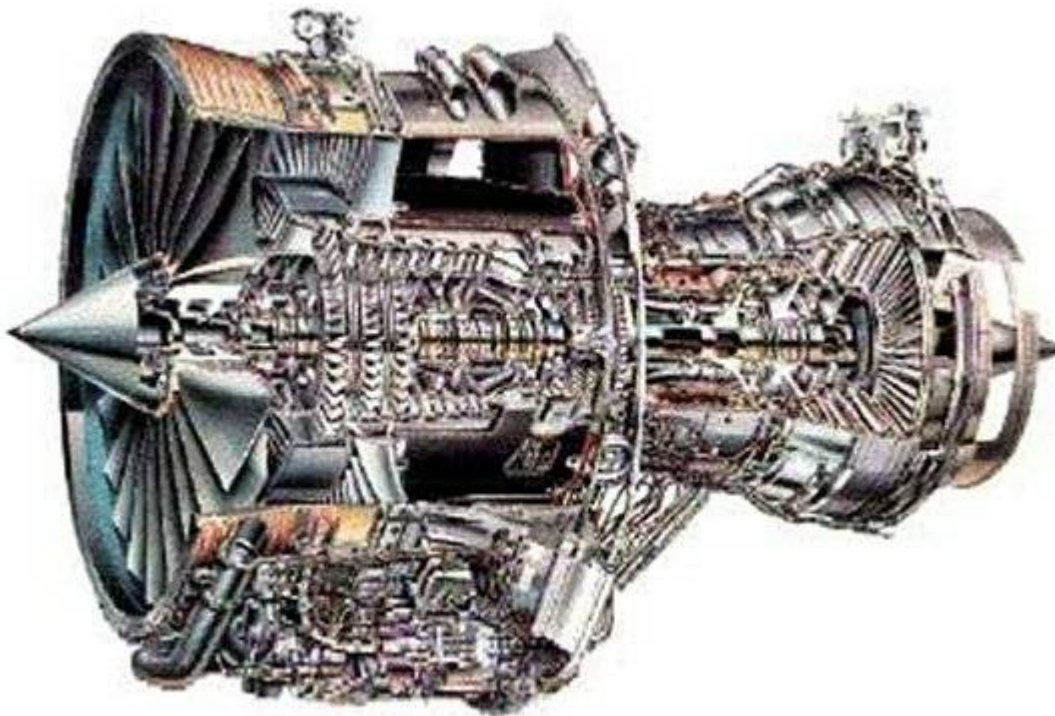
Cut-away of the Rolls-Royce RB211-535 turbofan

Using these images and other diagrams of the RB211-535 engine, we can obtain approximate dimensions of the engine's rotary disks for comparison to the item found in the Pentagon rubble. Our best estimate is that the engine's twelve compressor disk hubs (without blades attached) are about 36% the width of the fan. The five turbine disk hubs appear to be slightly smaller at approximately 34% the fan diameter. According to [Brassey's World Aircraft & Systems Directory](#) and [Jane's](#), the fan diameter of the RB211-535E4B engine is 74.5 inches (189.2 cm). It then follows that the compressor disk hubs are approximately 27 inches (69 cm) across while the turbine disk hubs are about 25 inches (63.5 cm) in diameter. Both of these dimensions fit within the range of values estimated for the engine component pictured in the wreckage at the Pentagon.

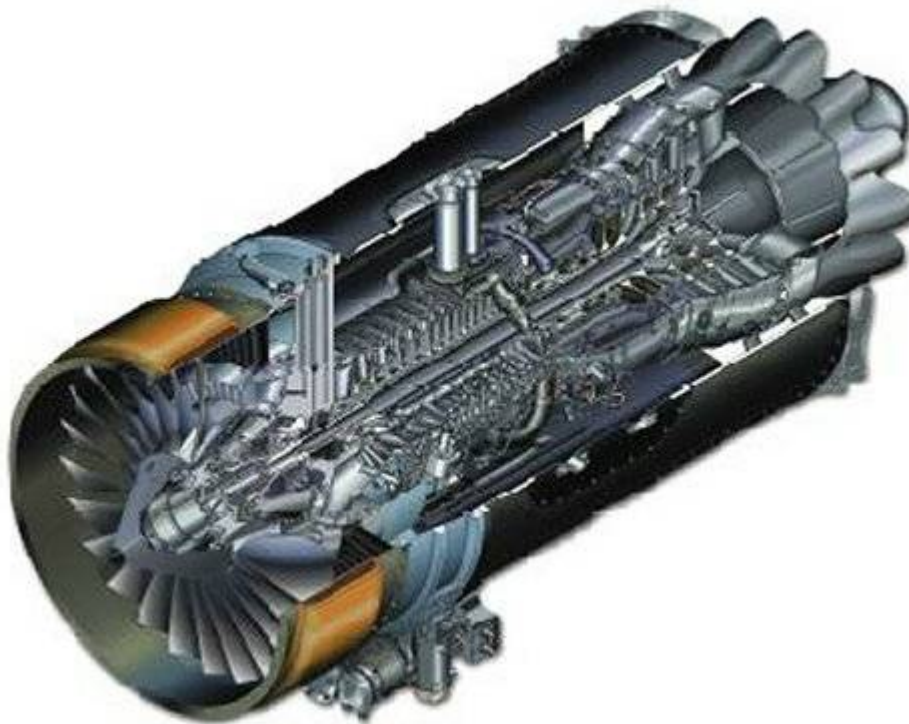
The Global Hawk, meanwhile, is powered by a single [Rolls-Royce AE3007H](#) turbofan. The AE3007 is built by the Allison Engine division of Rolls-Royce located in Indianapolis, Indiana.

Rolls-Royce AE3007 turbofan

Using photos and cut-away drawings of these three engines, we can estimate the diameters of the compressor and turbine rotor hubs just as we did for the RB211. While the compressor and turbine disks on the J57 and JT8D are larger by percentage than those of the RB211, the maximum diameters of all three engines are considerably smaller as summarized in the following table.

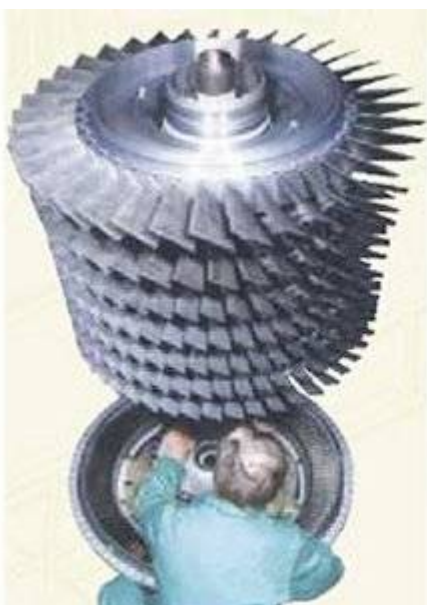
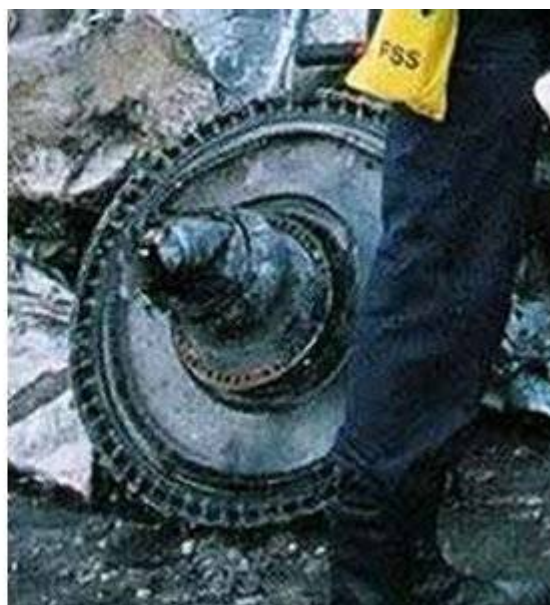
Comparison of intermediate pressure compressor stages on the RB211 to the wreckage

One similarity between the two photos can be seen in the cleats along the edge of the Pentagon object. These devices are called dovetail slots and provide attachment points for the compressor blades. The shapes of these slots on the Pentagon wreckage appear to match those on the RB211 assembly shown on the left. Furthermore, the "nosepiece" jutting out from the center of the disk in the Pentagon photo shares commonalities with the central shaft visible in the RB211 photo.

The above analysis indicates that the Pentagon debris does in fact match the characteristics of a rotor disk from the Rolls-Royce RB211-535. The wreckage is most likely a compressor stage given the shape of the dovetail slots. It is difficult to be certain exactly which compressor disk it is since the six rotors of the intermediate pressure section and six high pressure compressor disks are of similar size. The primary difference from one compressor to the next is the smaller span of the compressor blades as the air flows further into the engine, but these blades are no longer attached to the wreckage. However, additional clues in the photo suggest the rotor disk is probably from the high pressure section or perhaps the very last disk of the intermediate pressure compressors.

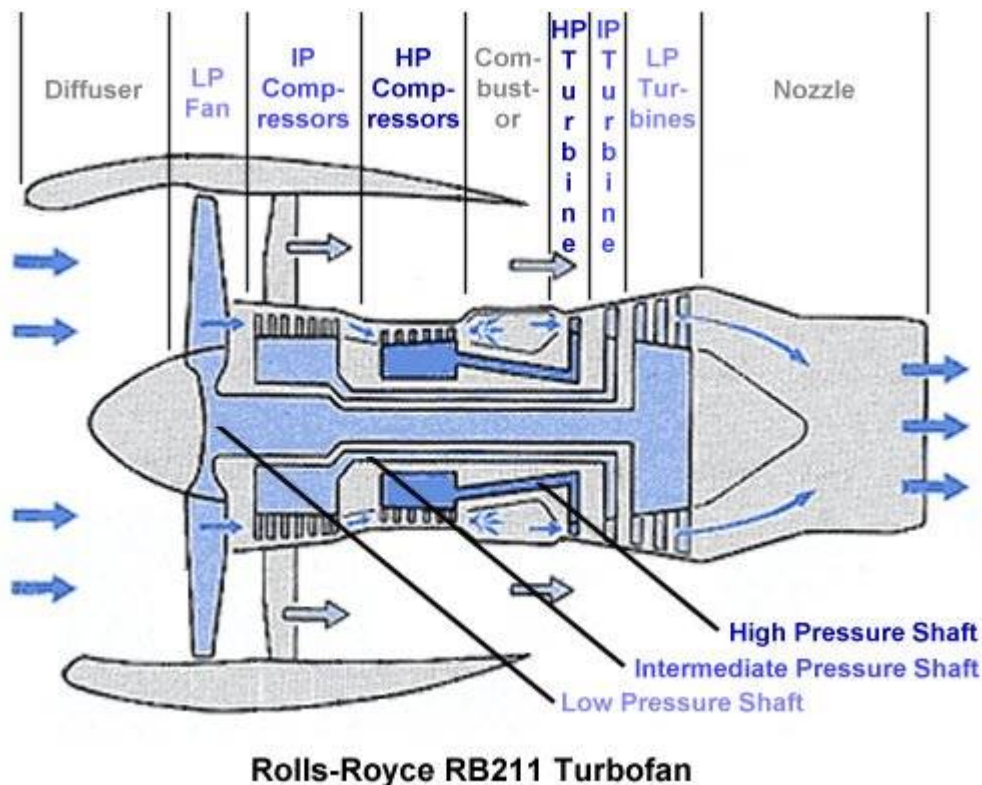
We believe the disk is most likely a high pressure compressor because of the shape of the piece jutting from its center. This item is part of the central shaft that runs the length of the engine to connect the rotating stages of the fan, compressor, and turbine. The RB211 is described as a triple-shaft or triple-spool turbofan since it uses three concentric shafts to drive the various rotating elements of the engine. These shafts are differentiated by the relative pressure of the gases passing through the rotor stages attached to them. The longest shaft with the smallest diameter located closest to the centerline connects the low pressure (LP) engine components. This shaft is rotated by the LP turbines, located just ahead of the nozzle, and drives the large fan at the front of the engine.

RB211 schematic illustrating the low, intermediate, and high pressure shafts

The LP shaft rotates within a shorter, larger diameter shaft that drives the intermediate pressure (IP) system. This shaft rotates at a higher rate and connects the IP turbine stage to the six IP compressor disks. The third concentric shaft is the shortest with the largest diameter and highest rate of rotation to drive the engine's high pressure (HP) system. This shaft connects the HP turbine to the six HP compressors. The debris photographed at the Pentagon appears to be connected to three concentric shafts of increasing diameter, suggesting that it most likely comes from the high pressure system of a triple-spool turbofan like the RB211-535.

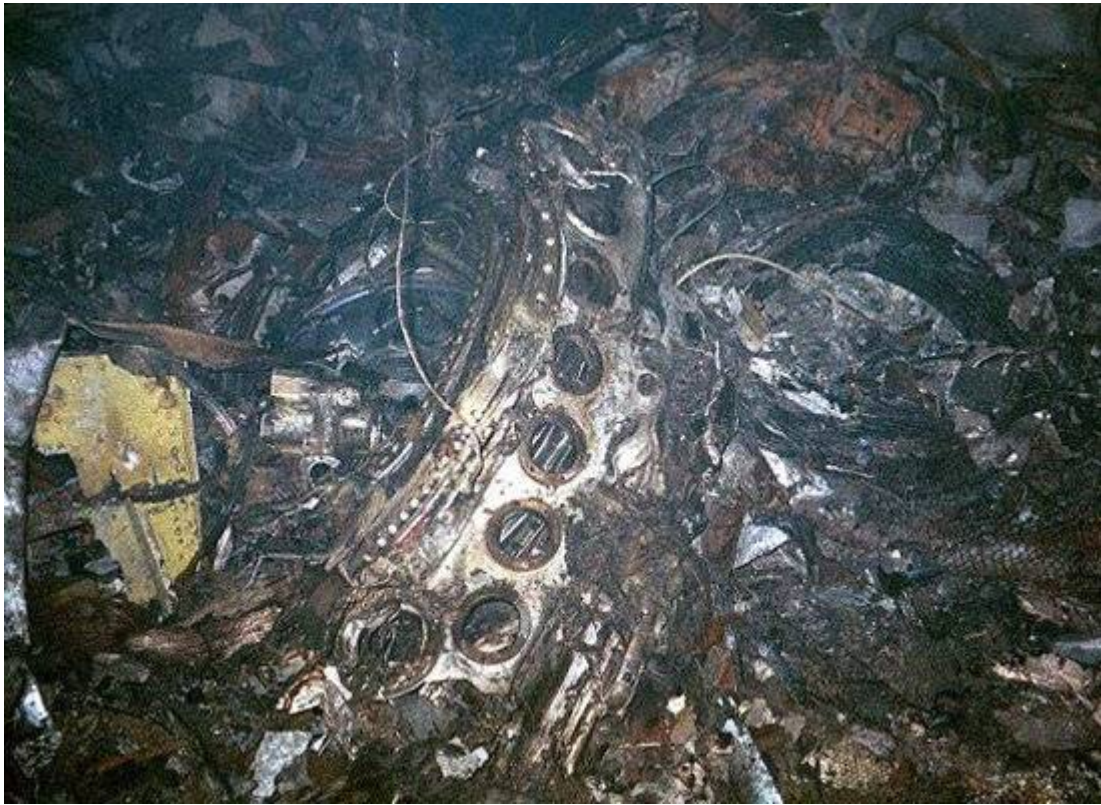
Another piece of engine debris found at the Pentagon

This item appears to be part of the casing of the combustion section. This portion of a jet engine is located aft of the compressors, and it is here that the high pressure air is mixed with fuel and ignited. The circumference of this circular casing contains several holes through which fuel injectors spray the jet fuel needed for combustion. The number, size, and shape of these nozzle holes is generally unique to a particular engine type and can be used to identify the engine model it comes from. Based on the curvature of the debris, the piece shown here appears to be about half of the total combustor case. We can count six nozzle ports along its circumference from the region nearest the floor around to the top, which represents about one-third of the total case. We can also see six screw holes along the circumference of each nozzle port that are used to attach the fuel injectors.

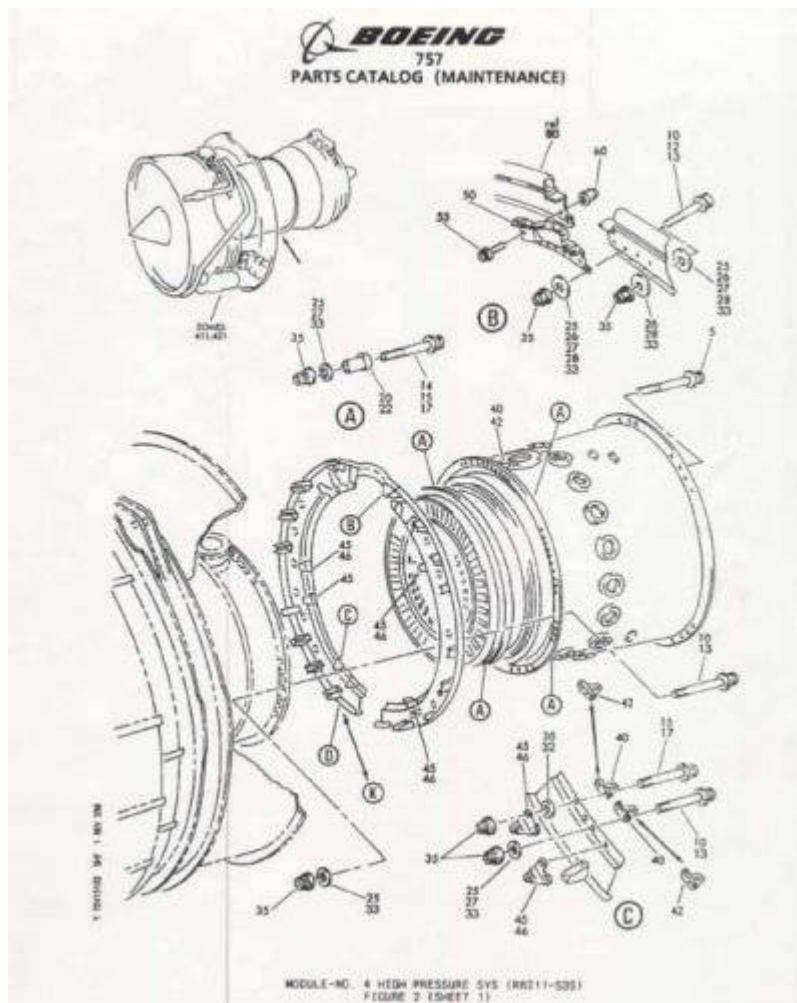
The best photos we have found illustrating the design of this part on the RB211-535 series engine come from the Boeing 757 maintenance manual. A diagram from this manual shown below illustrates components of the RB211-535 high pressure system and its location relative to the rest of the engine.

Components of the RB211-535 illustrated in the 757 maintenance manual

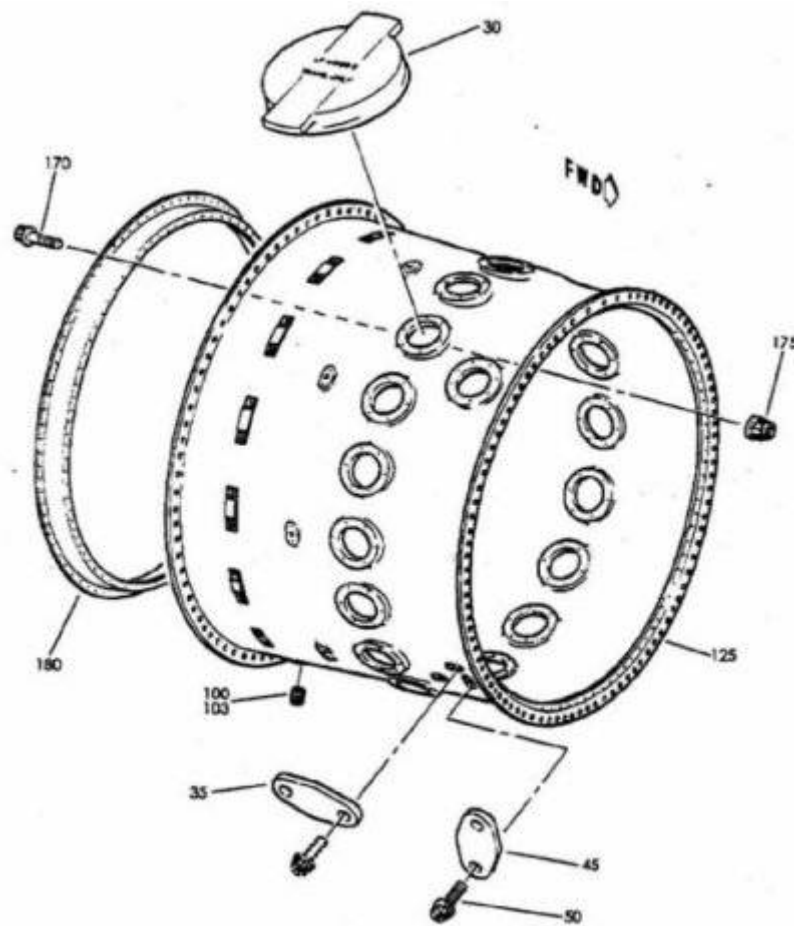
COMBUSTION OUTER CASE (RB211-535)
FIGURE 1 (SHEET 4)

An even better close-up view of the combustion case is provided below. Note the overall design pattern of the fuel injector ports including the shape of the holes, the spacing between them, and their relative sizes compared to the diameter of the case itself. Also note the locations of the six screw holes around the circumference of each nozzle port. There also appear to be a total of 18 injector holes around the circumference of this casing, and six of these holes can be found over one-third of the case diameter. All of these measurements match up perfectly to the Pentagon photo.

RB211-535 combustion outer case

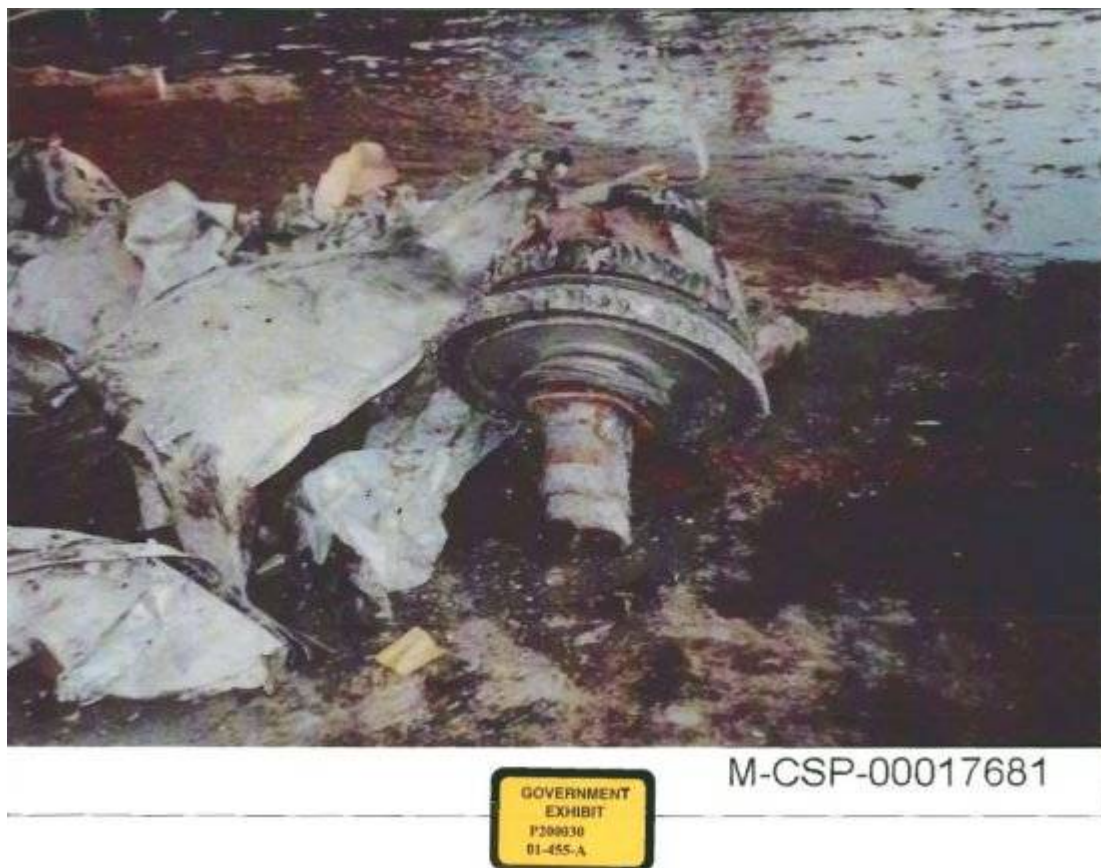
Piece of engine debris photographed at the Pentagon

This debris appears to contain two rotating engine disks with part of the engine's central shaft protruding forward. Behind the two disks is another component called a frame. Frames are fixed, non-rotating components that provide attachment points holding the engine together. This debris must come from the aft section of an engine given the shape of the blade attachment points visible along the circumference of the two rotating disks. These attachments have a highly cambered, or curved, banana-like shape indicative of the blades used in the turbine section of a jet engine. The blades used on fan and compressor stages, by comparison, have a much straighter and less curved shape.

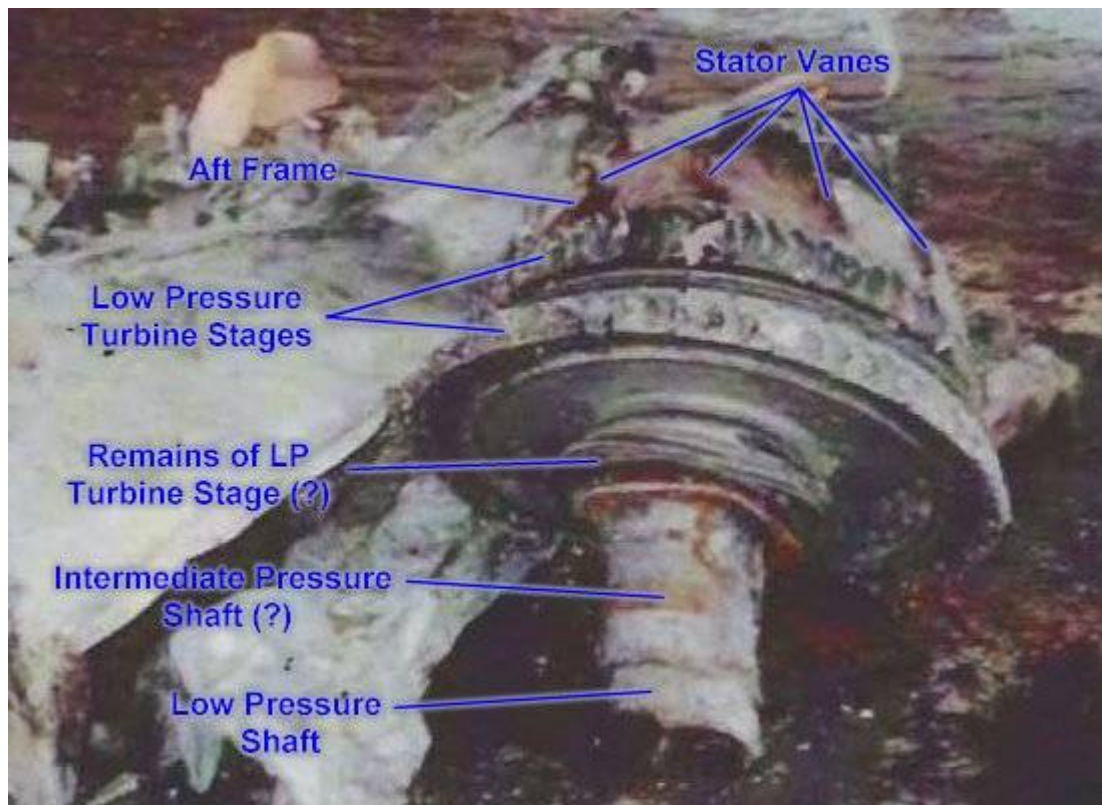
Closer view of the turbine section debris

The RB211-535 engine used on the 757 contains five turbine disks--three low pressure turbines that power the fan, one intermediate pressure turbine driving the intermediate pressure compressors, and one high pressure turbine that turns the high pressure compressors. The debris shown here contains two of the three low pressure turbines and possibly the remains of the third. The protruding shaft also appears to be composed of two separate shafts of differing diameter. A small portion of the inner shaft, from the engine's low pressure system, appears to protrude from inside a second larger diameter shaft surrounding it. This larger diameter shaft corresponds to the intermediate pressure system and would connect to an additional turbine disk that is no longer attached.

Though it is difficult to conclusively identify these components as part of an RB211-535 engine without better pictures of an intact engine for comparison, perhaps the most identifiable object shown in debris is the aft frame. Along the circumference of this frame are several fixed blades called stators that help guide the air as it flows through the engine. We can see the remains of four of these stators in the photo over about a third of its diameter.

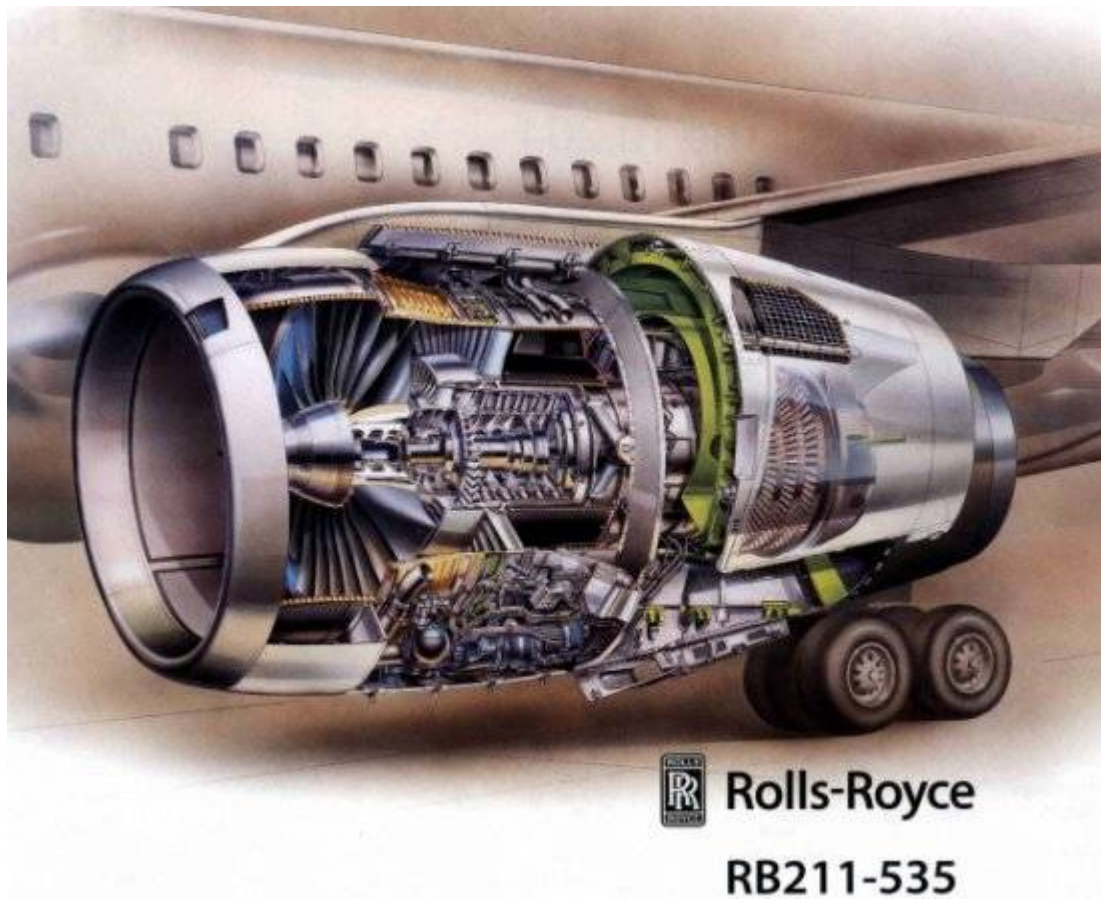
Cut-away diagram of the RB211-535 fitted to a Boeing 757

The above illustration from Rolls-Royce shows another cut-away of the RB211-535 that provides a good view of the internal components of the engine. In particular, note the frame just aft of the turbine stages. The spacing of the stator vanes shown here matches those seen in the Pentagon photo well and provides additional evidence that the debris is in fact from an RB211 engine.

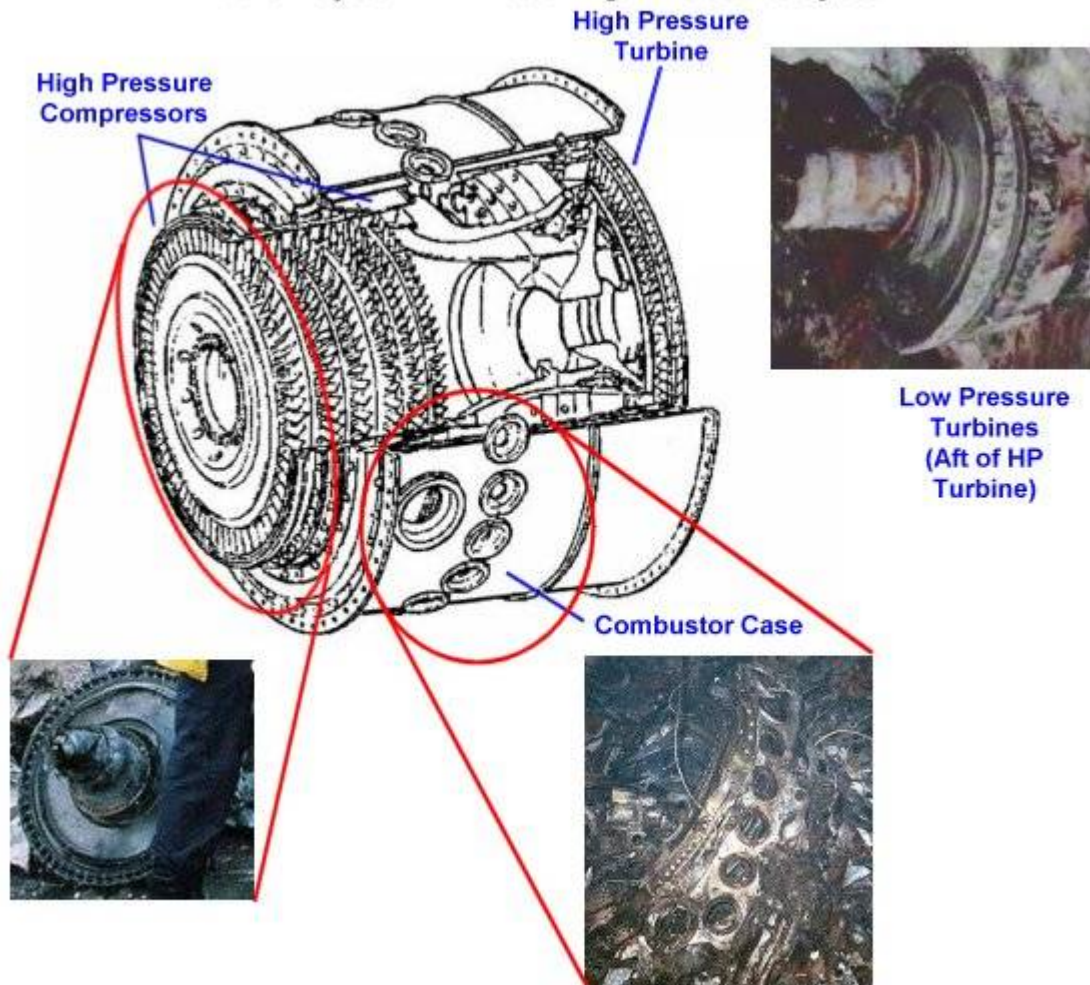
Rolls-Royce RB211-535 High Pressure System

RB211 high pressure system containing six compressor disks, combustors, and a turbine disk

To give a better idea of how the three engine components we have discussed relate to one another, the above image shows a diagram of the high pressure system within the RB211-535 engine. Also included are the objects identified in the Pentagon wreckage and their relative locations within the engine. As discussed in the main article, all three of these pieces of debris are identical matches to or at least consistent with the components found in the Rolls-Royce RB211-535 turbofan aboard a Boeing 757.
